Agreement No. CE 60/2017 (EP)

Environmental Team for Tung Chung New Town Extension (East) - Design and Construction

Monthly Environmental Monitoring & Audit Report for December 2022

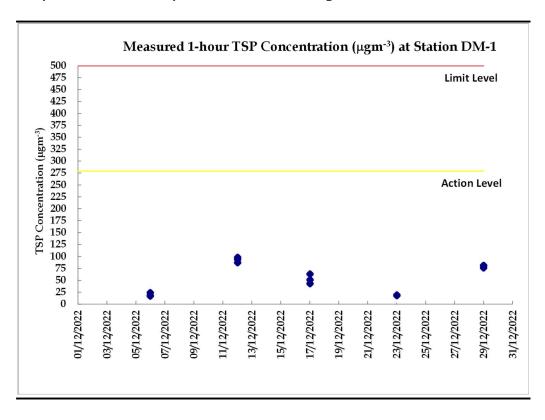
Figure E3 Graphical Presentation for 1-hr TSP Monitoring at Station DM-1

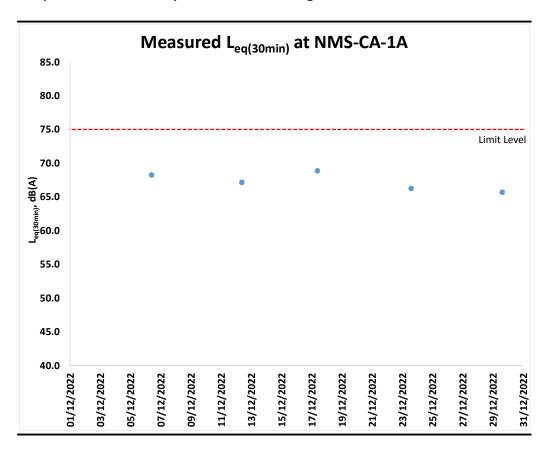
Figure F3.1 Graphical Presentation for Noise Monitoring at Station NMS-CA-1A

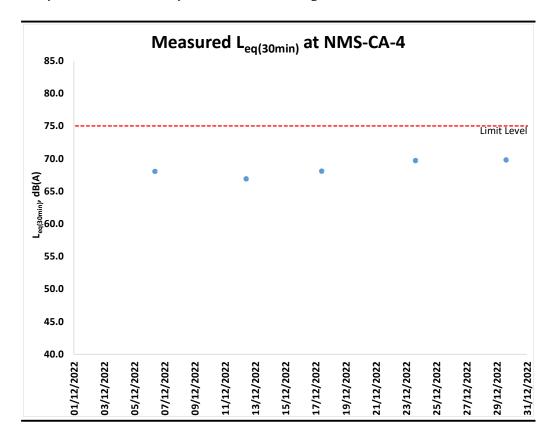
Figure F3.2 Graphical Presentation for Noise Monitoring at Station NMS-CA-4

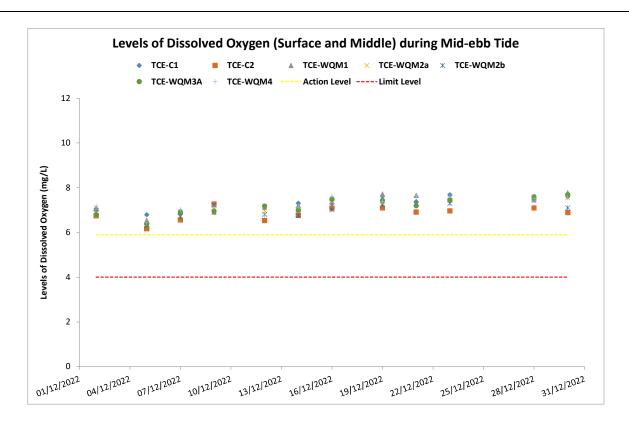
Figure 1: Levels of Dissolved Oxygen (Surface and Middle) (mg/L) recorded at Mid-ebb Tide during the Water Quality Monitoring between 1 to 31 December 2022

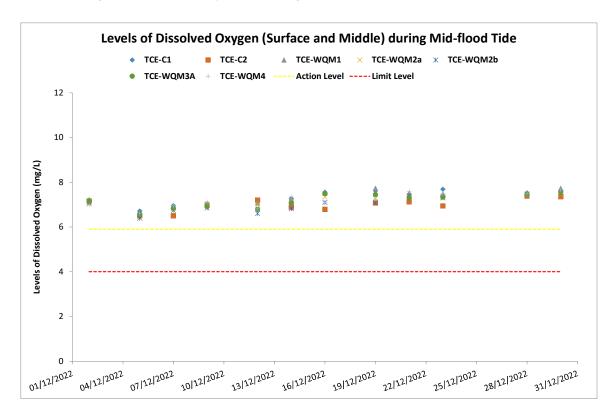
Figure 2: Levels of Dissolved Oxygen (Surface and Middle) (mg/L) recorded at Mid-flood Tide during the Water Quality Monitoring between 1 to 31 December 2022

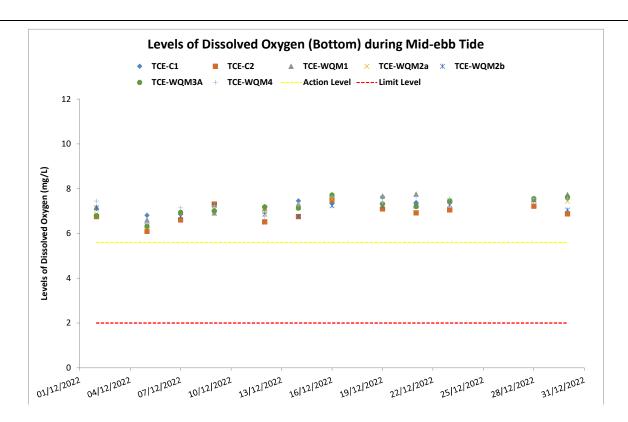
Figure 3: Levels of Dissolved Oxygen (Bottom) (mg/L) recorded at Mid-ebb Tide during the Water Quality Monitoring between 1 to 31 December 2022

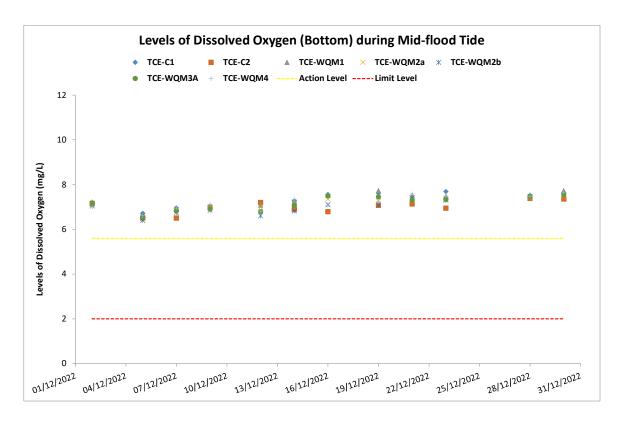
Figure 4: Levels of Dissolved Oxygen (Bottom) (mg/L) recorded at Mid-flood Tide during the Water Quality Monitoring between 1 to 31 December 2022

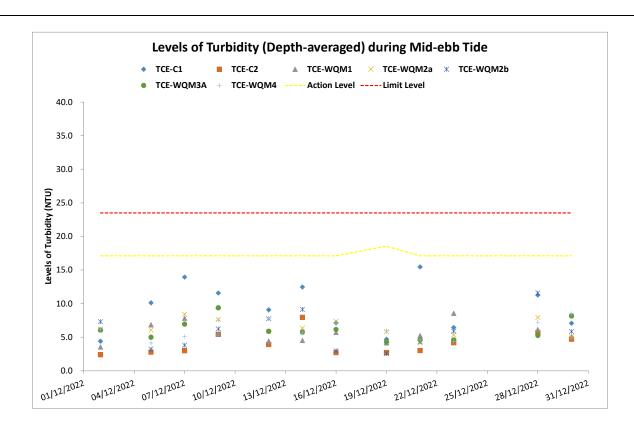
Figure 5: Levels of Turbidity (Depth-averaged) (NTU) recorded at Mid-ebb Tide during the Water Quality Monitoring between 1 to 31 December 2022

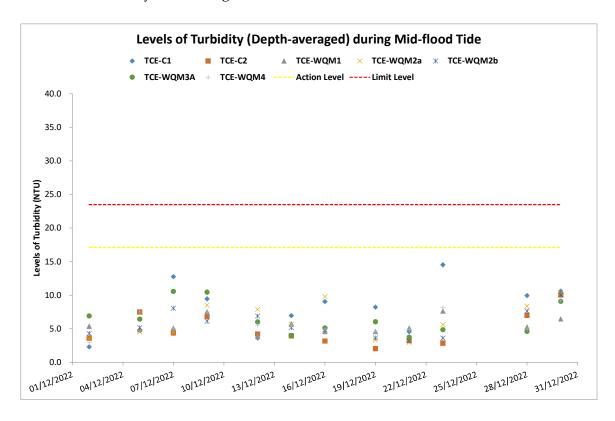
Figure 6: Levels of Turbidity (Depth-averaged) (NTU) recorded at Mid-flood Tide during the Water Quality Monitoring between 1 to 31 December 2022

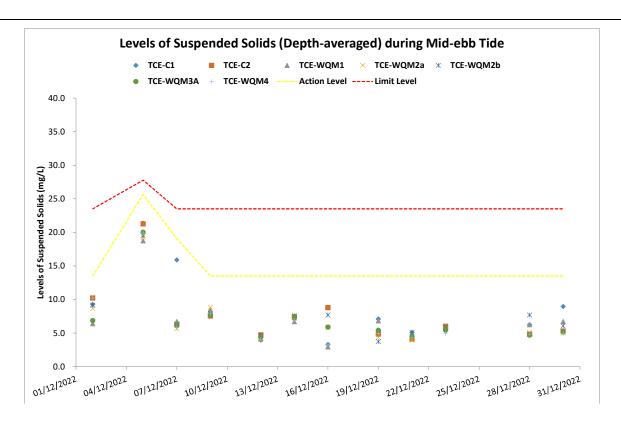
Figure 7: Levels of Suspended Solids (Depth-averaged) (mg/L) recorded at Mid-ebb Tide during the Water Quality Monitoring between 1 to 31 December 2022

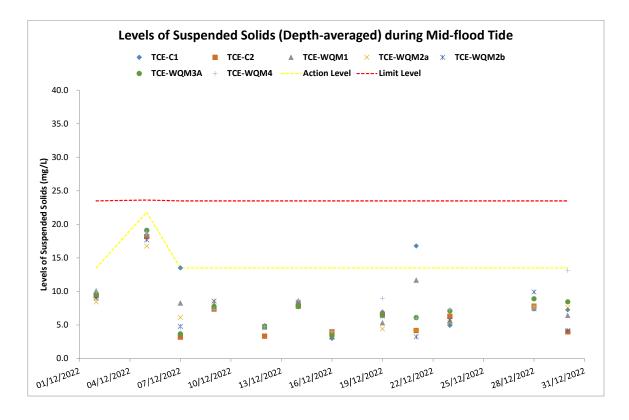
Figure 8: Levels of Suspended Solids (Depth-averaged) (mg/L) recorded at Mid-flood Tide during the Water Quality Monitoring between 1 to 31 December 2022

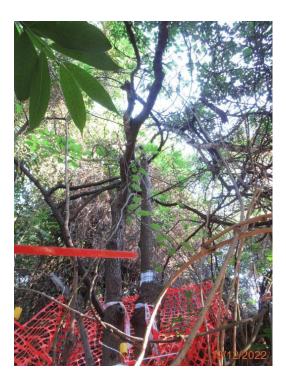
Photo 1 – General view of tree protection zone for preserved plant species of conservation importance

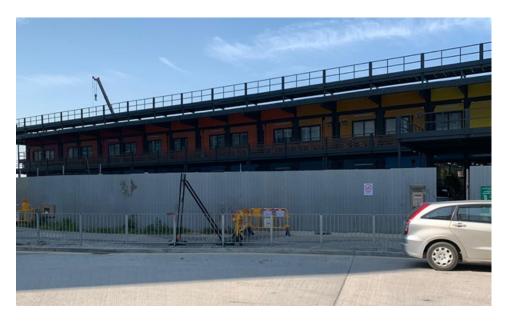
Photo 2 – Erection of site hoardings in unobtrusive colours

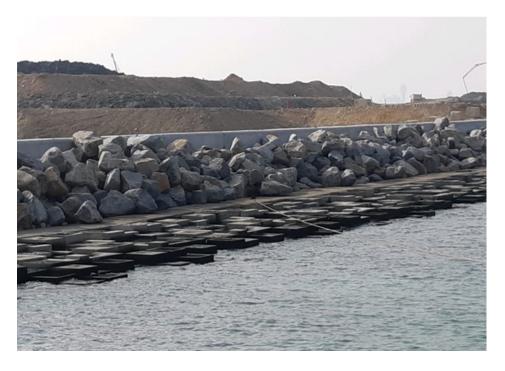
Photo 3 - Natural Rock Material/ Planting for Artificial Seawall

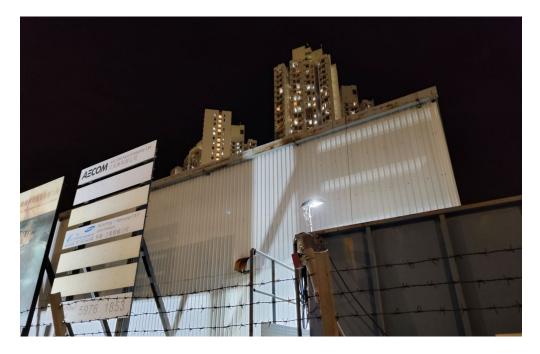
Photo 4 – Control of night-time lighting using light hooding
