Tung Chung New Town Extension

8th PLG Meeting
Date : 15 February 2023

土木工程拓展署
CIVIL ENGINEERING AND
DEVELOPMENT DEPARTMENT

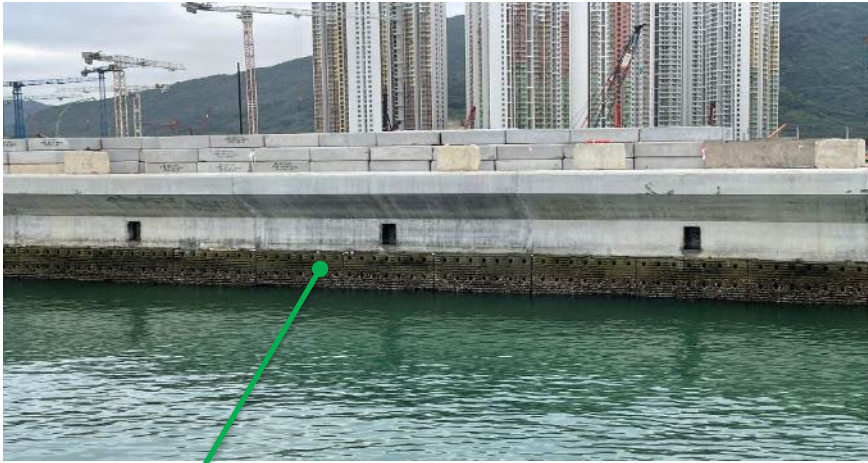
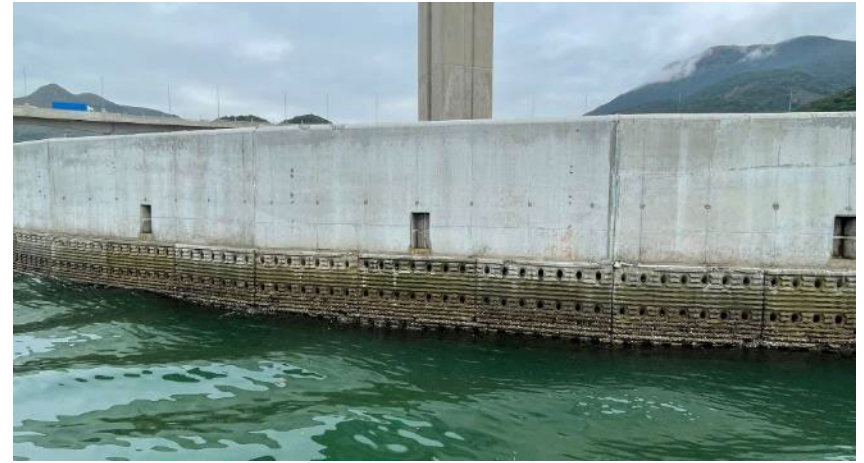
Thin film of algae observed

General View of Vertical Eco-shoreline

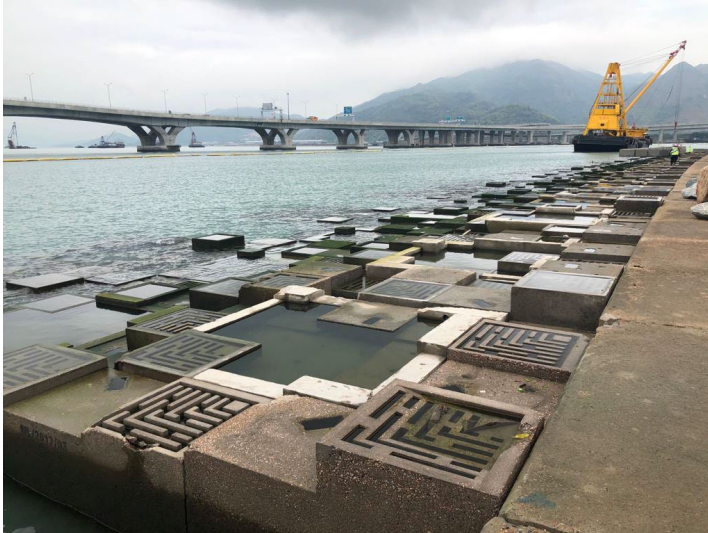
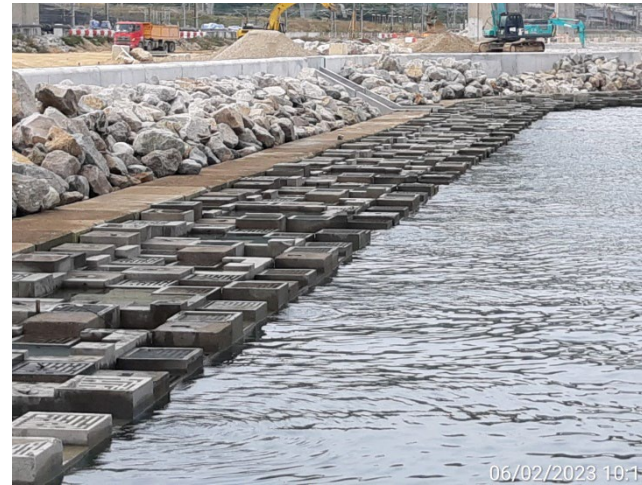
Rocky Eco-shoreline

General View of ES2(E)

General View of ES2

- Precasting of bio-concrete block in progress

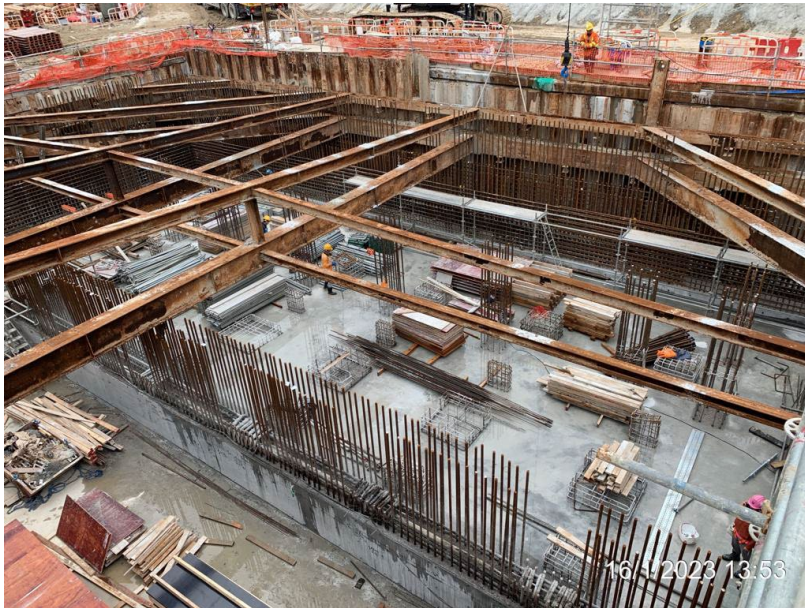
Salt Water Pumping Station (SWPS)

Construction Period
2021 Q4 to 2023 Q4

- ELS works
- R.C. structures

RC Structure for Pumping Station in progress

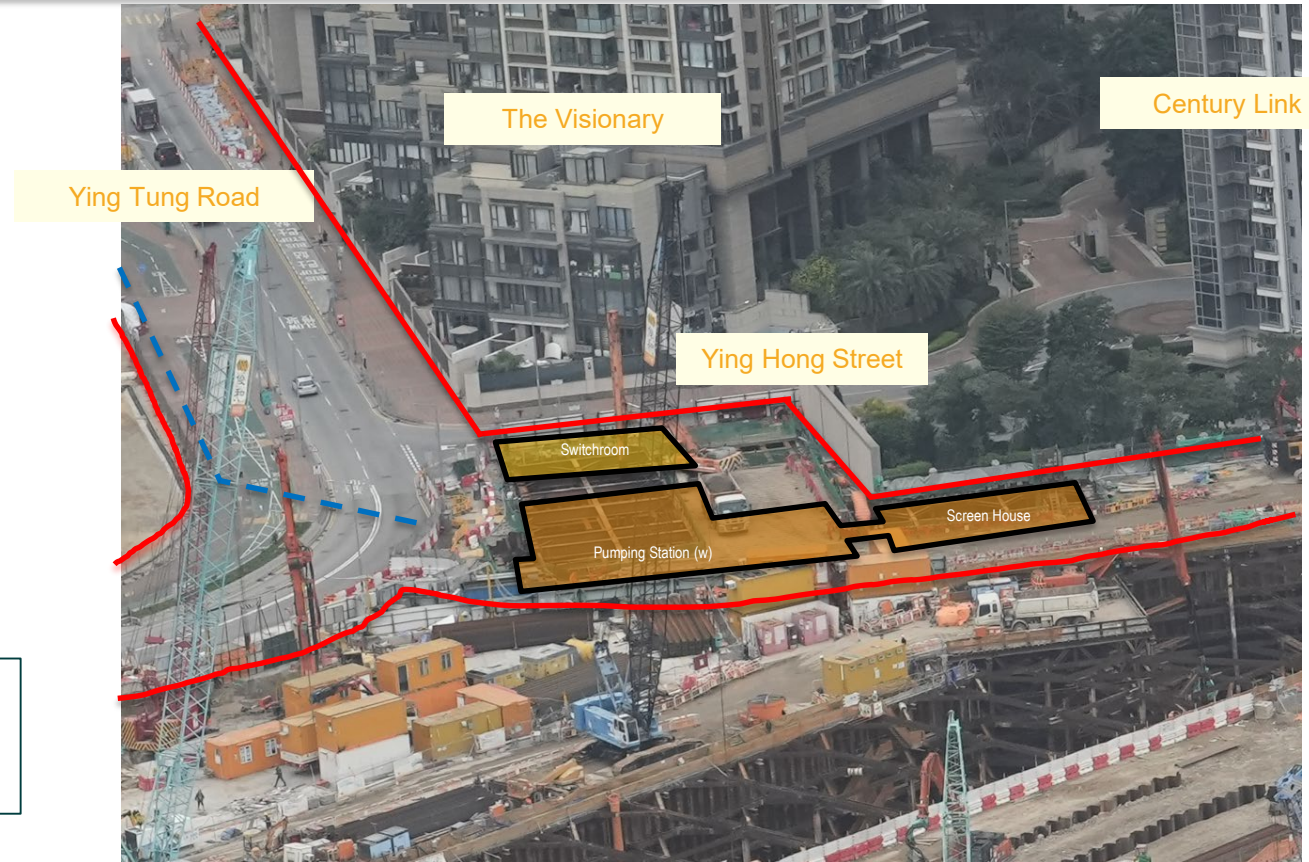
West Sewage Pumping Station (WSPS)

Construction Period
2021 Q3 to 2023 Q3

- ELS works
- R.C. structures

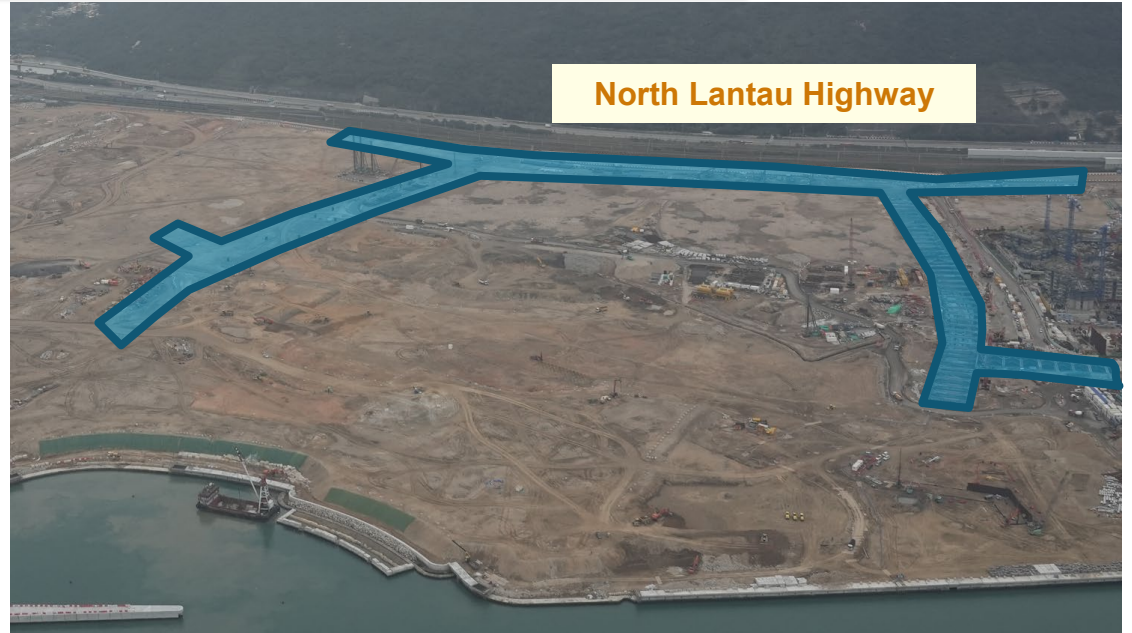
Common Utility Tunnel (CUT)

CUT Completion Date
2026 Q3

- ELS works
- Underground R.C. structures

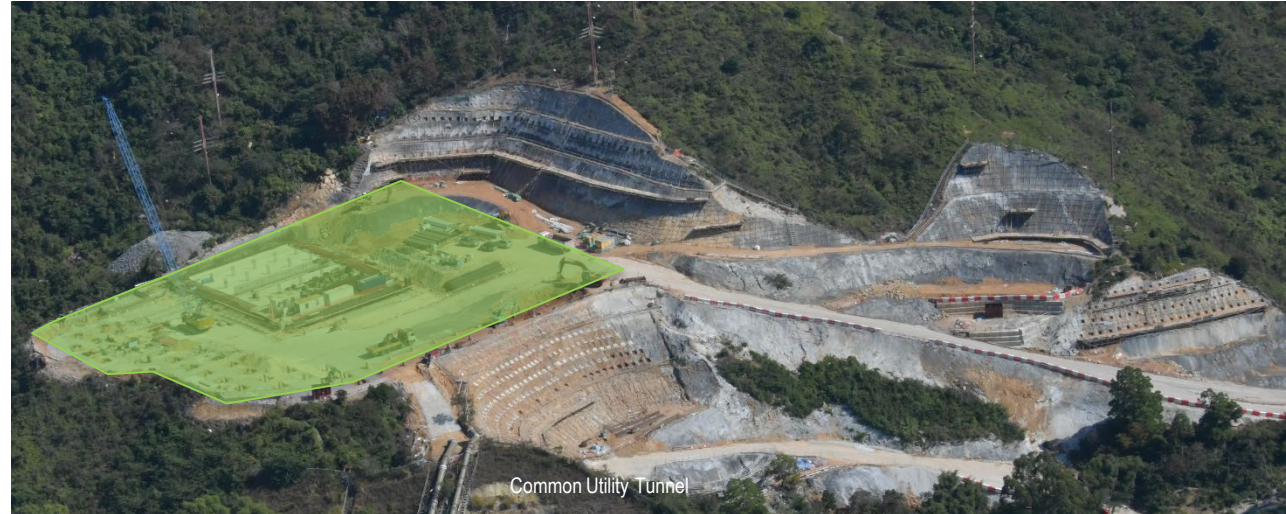
Fresh Water Service Reservoir

Construction Period
2022 Q2 to 2024 Q3

- Site formation
- Soil Nail Works
- R.C. structures

Rebar fixing of base slab of service reservoir

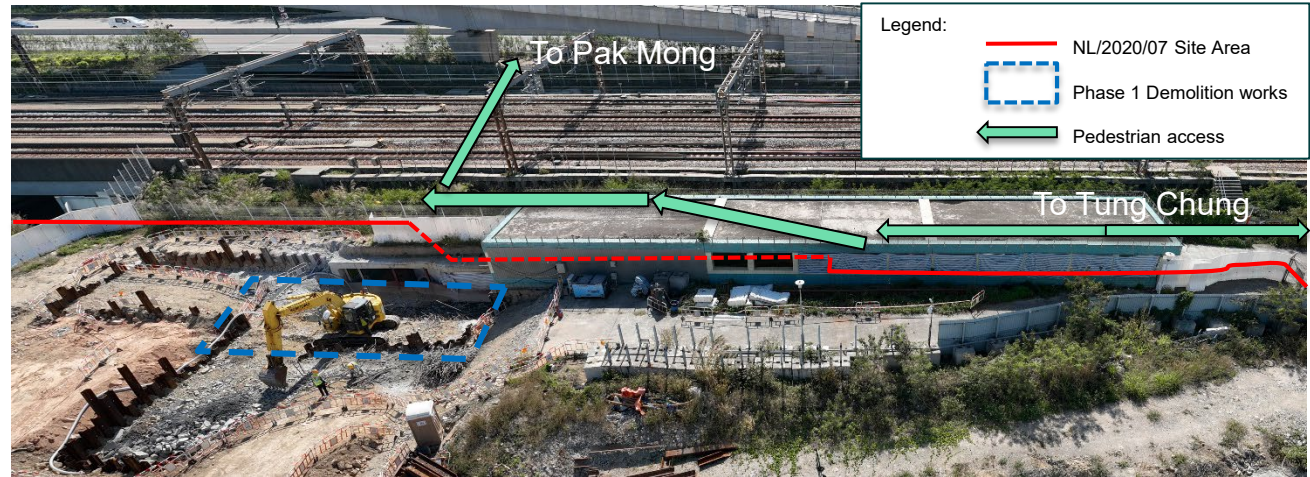
Pak Mong Subway Extension

Construction Period
2022 Q2 to 2024 Q3

- Demolition works
- R.C. structure & Steel frame roof

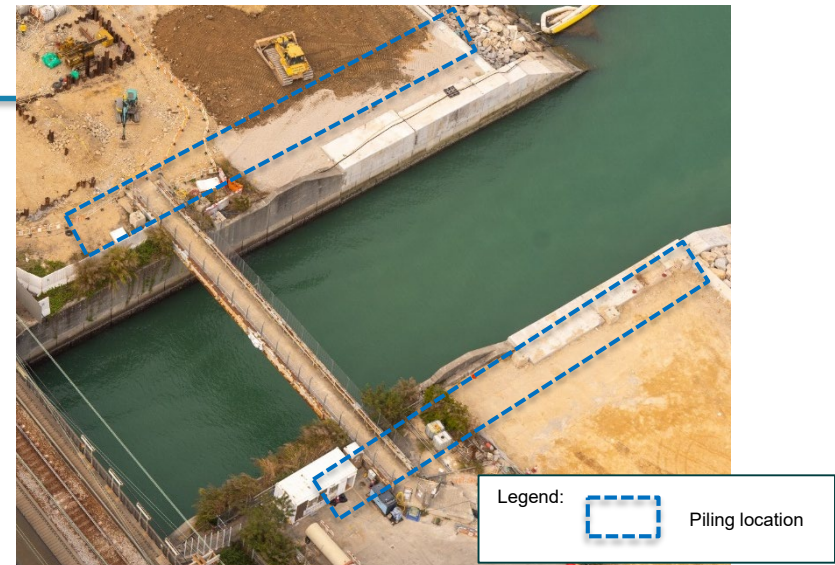
Pak Mong Channel Bridge

Construction Period
2023 Q1 to 2024 Q4

- Piling works
- Bridgeworks

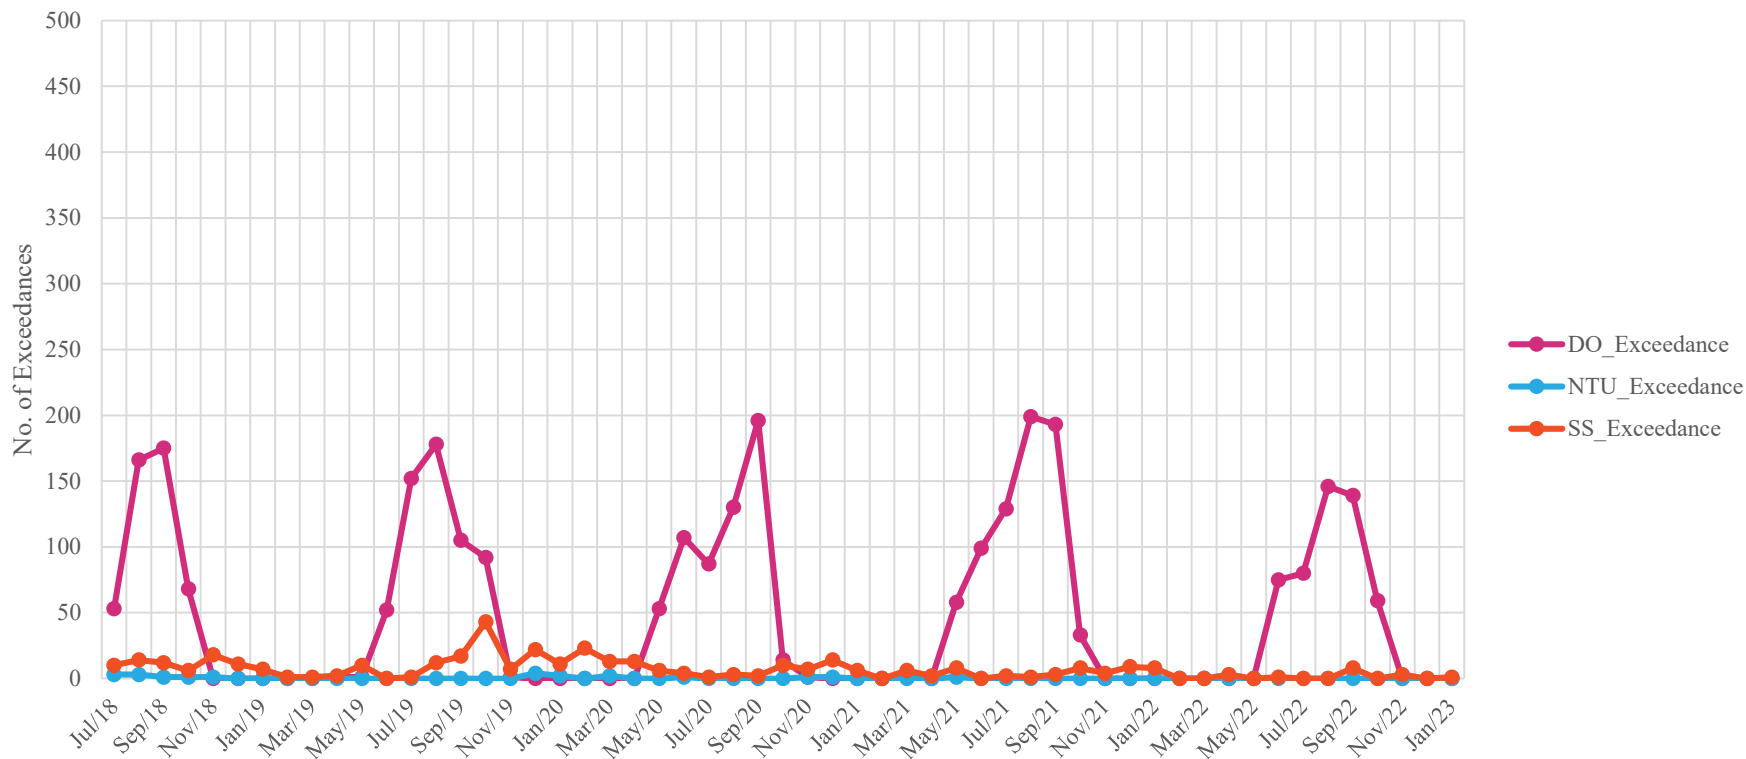
Tung Chung New Town Extension - Reclamation and Advance Works Exceedance Record of Water Quality Monitoring

The majority exceedances recorded were DO exceedances. Low levels of DO were recorded during summer period. This trend suggested the changes should be due to seasonal fluctuation.

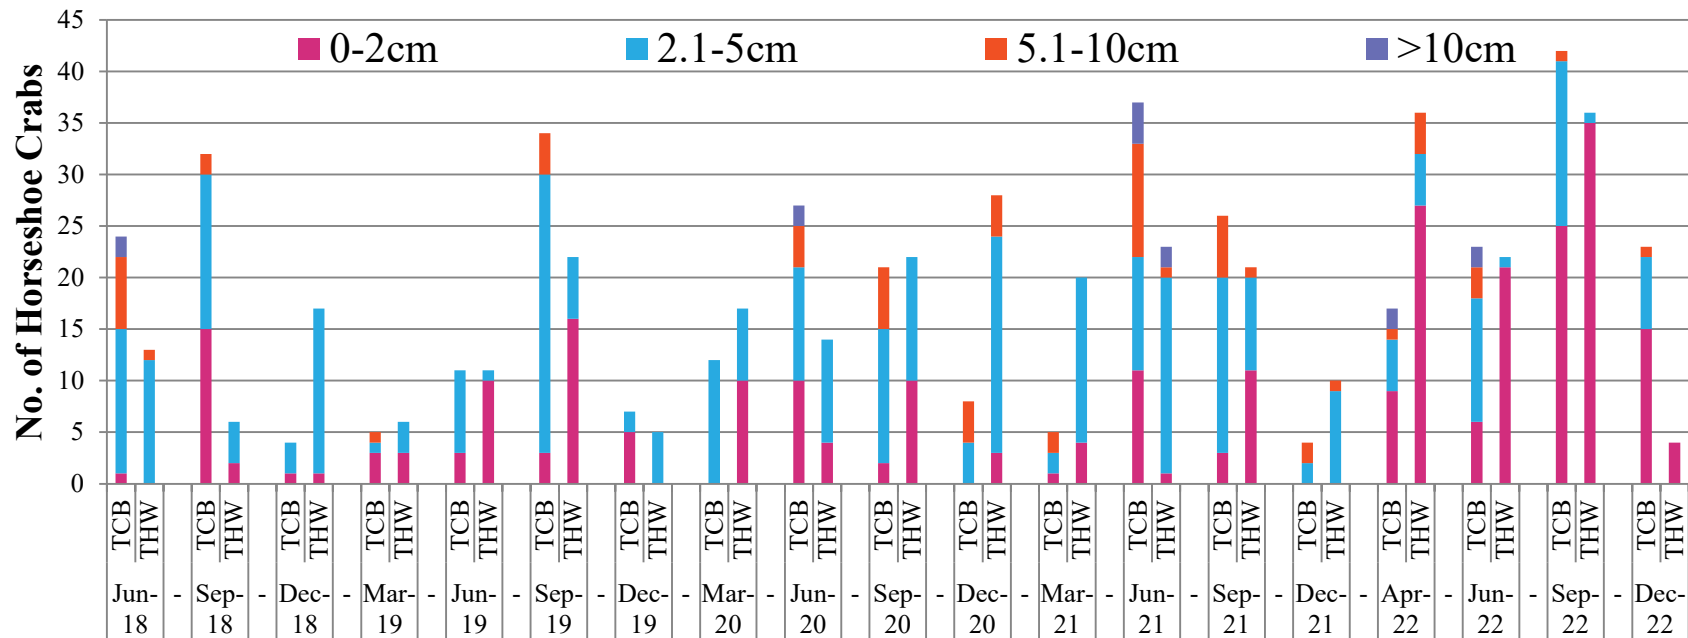
Size (Prosomal Width) of Horseshoe Crabs

- Numbers of horseshoe crabs varied over time and were generally higher in summer period (May – Sep)
- Small juvenile horseshoe crabs (prosomal width <2 cm) were recorded during all impact monitoring since Sep 2018

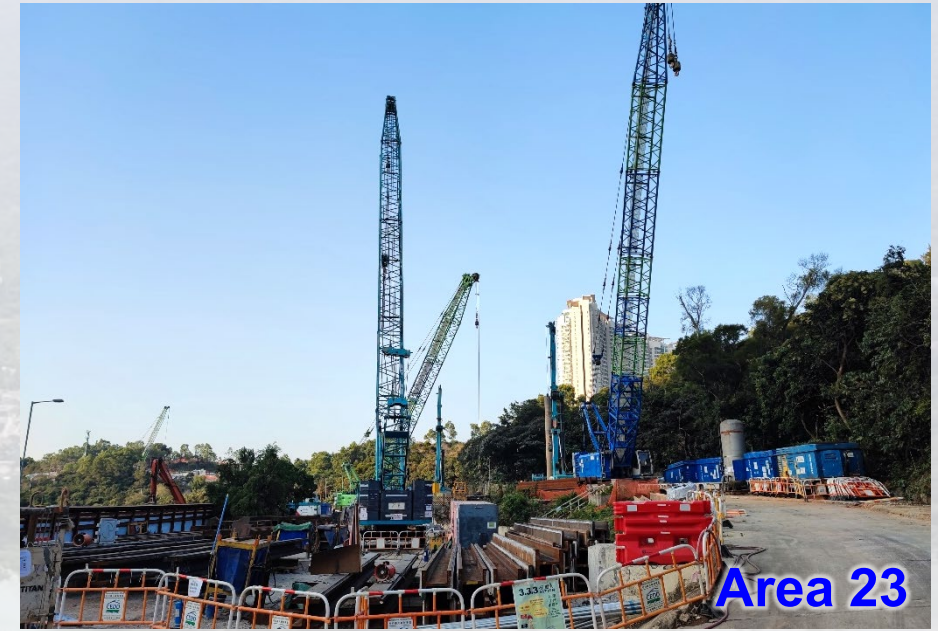
Progress of Area 23:

1. Demolition of the Tung Chung Community Services Complex completed.
2. Soldier pile wall construction for site formation works in progress.

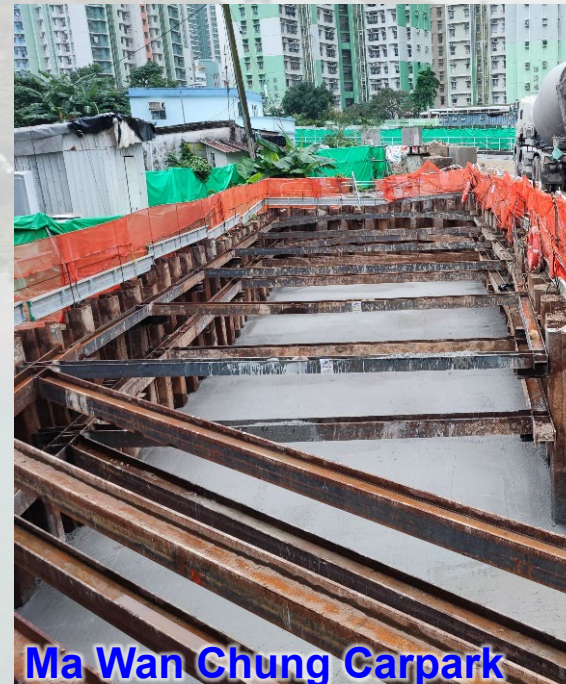
Progress of Ma Wan Chung Carpark:

1. Retaining wall construction in progress.

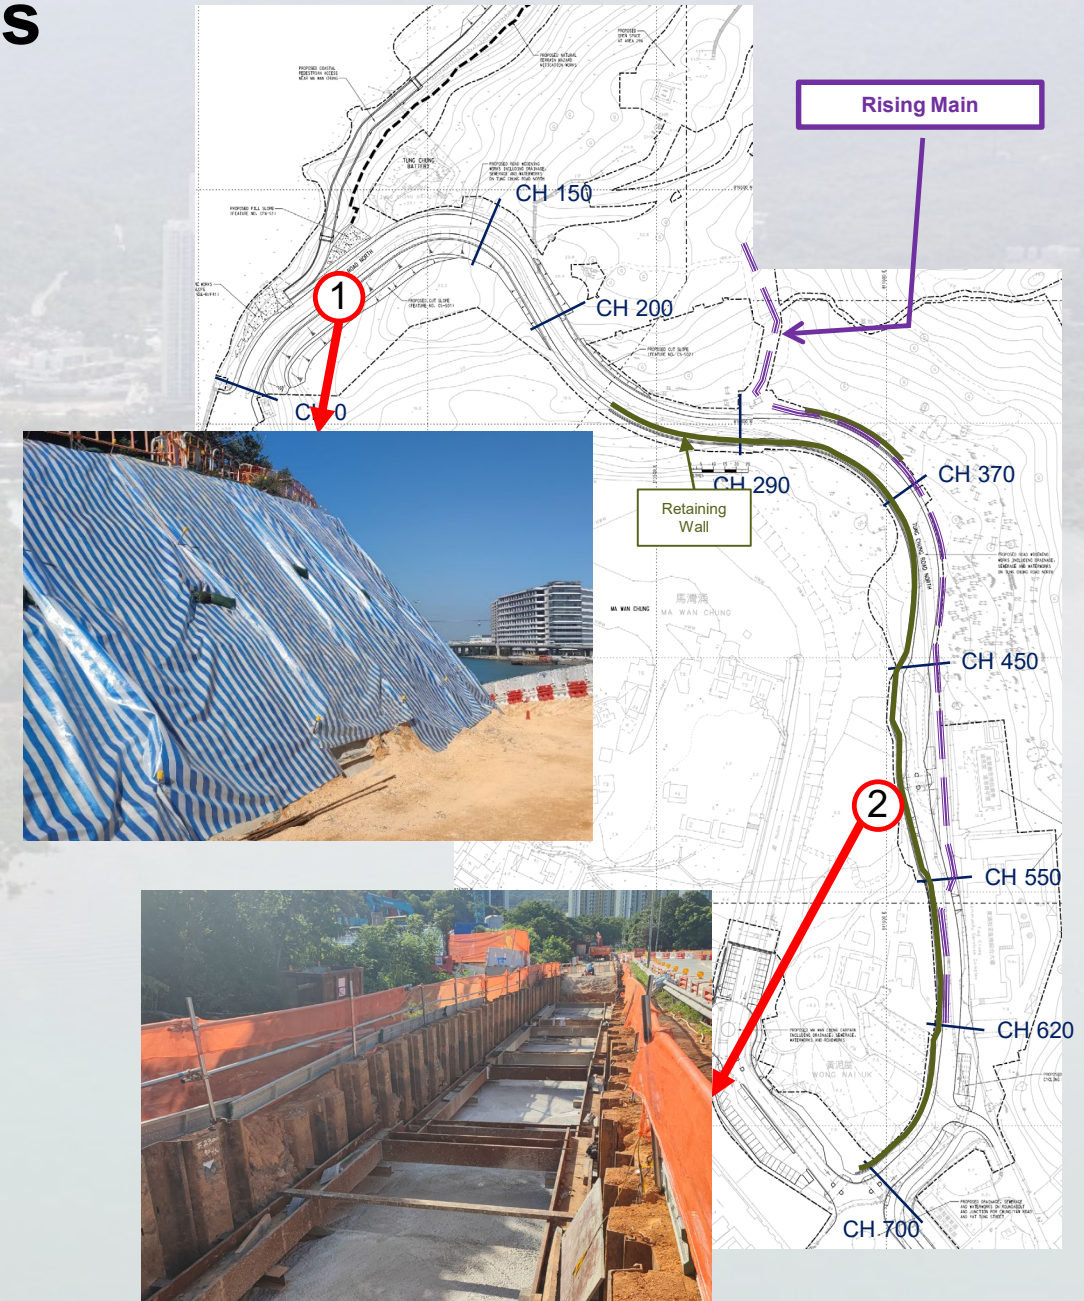
Progress of Tung Chung Road North:

1. Slope works in progress.
2. Construction of underground utilities and road works in progress.

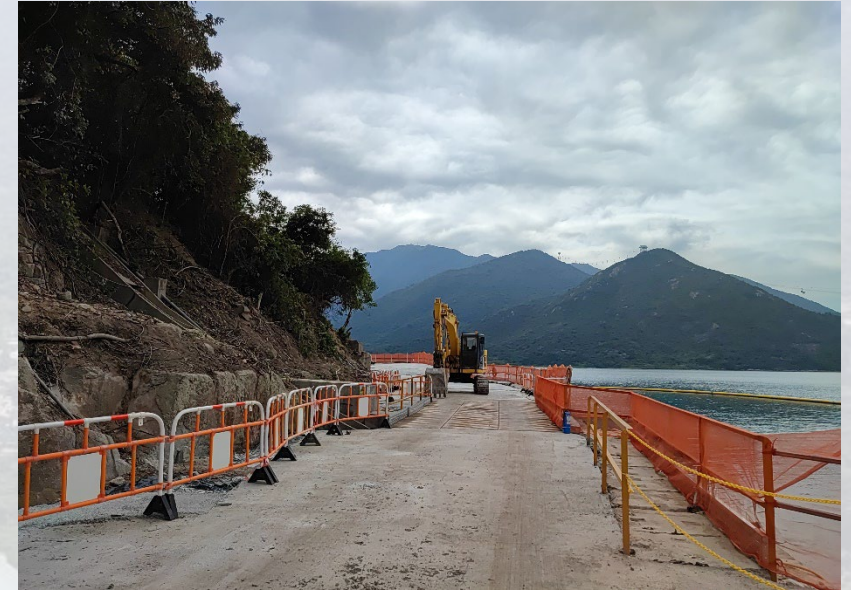
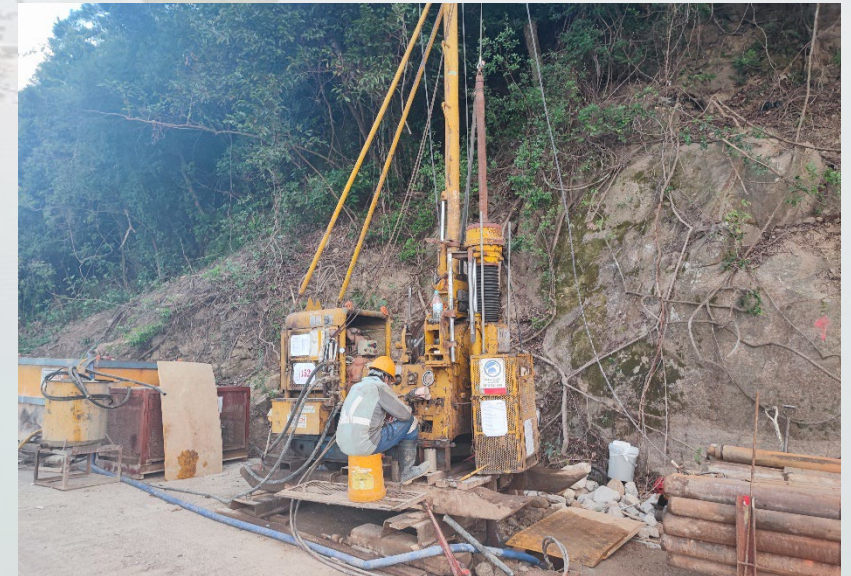
Progress of Coastal Pedestrian Access (CPA):

1. Formation of temporary site access in progress.
2. Ground investigation works in progress.

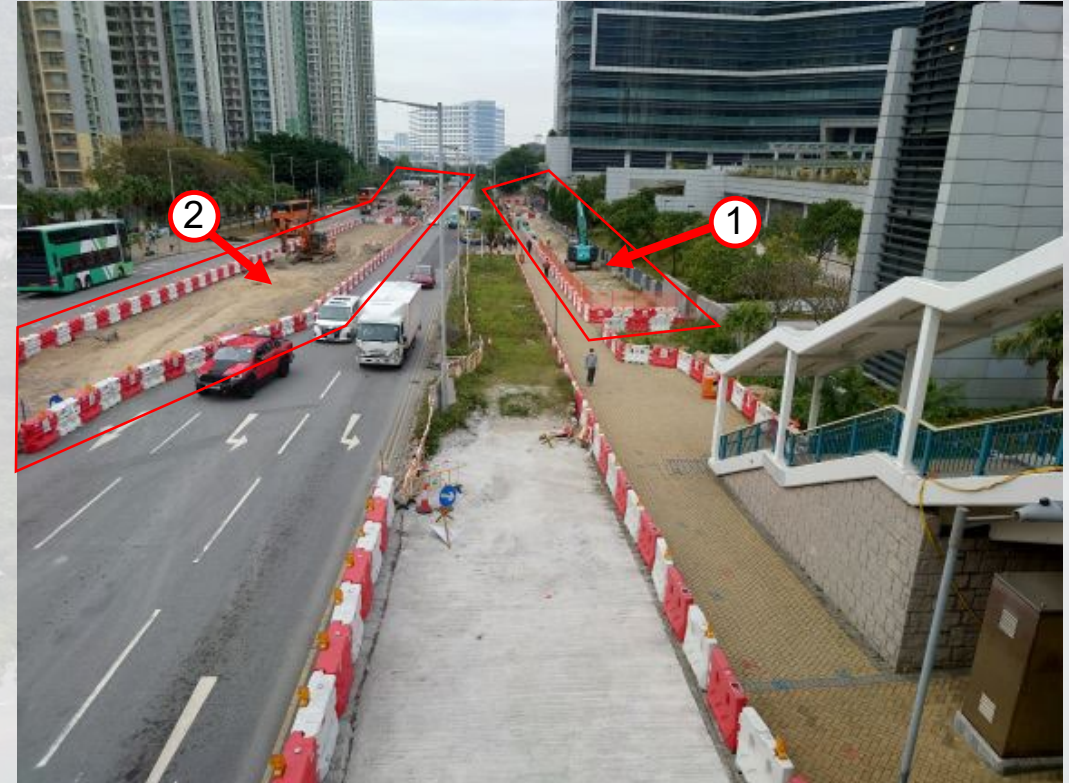
Progress of Chung Yan Road:

1. Construction of the covered walkway in progress.
2. Construction of underground utilities and road works in progress.

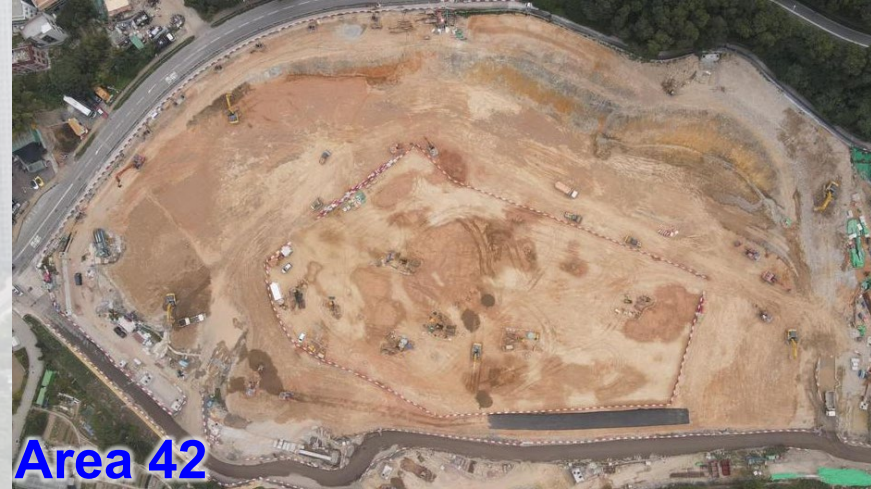
Progress of Area 42 and Area 46:

1. Site formation works in progress.

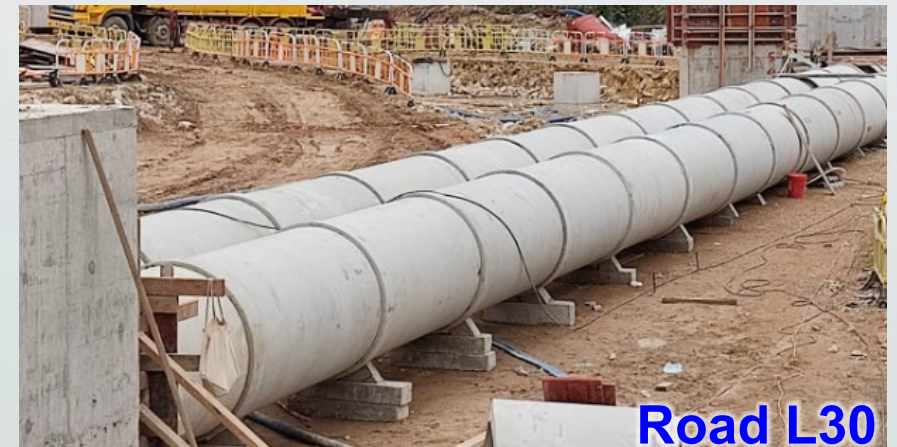
Progress of Road L30:

1. Construction of underground utilities and road works in progress.

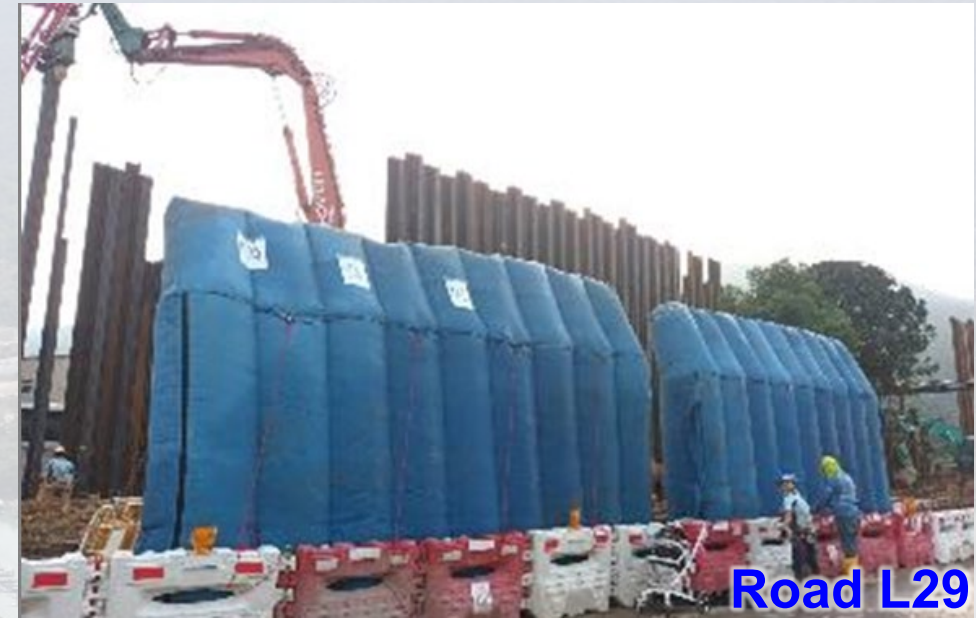
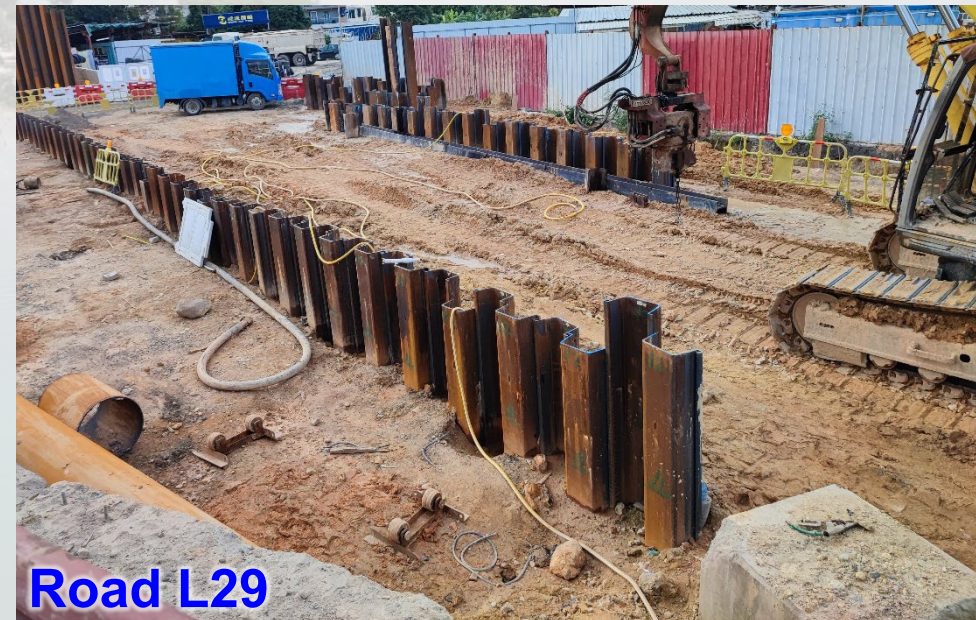
Progress of Road L29:

1. Works for temporary diversion of the Tung Chung Stream in progress.
2. Revitalisation works at Tung Chung Stream will be commenced soon.

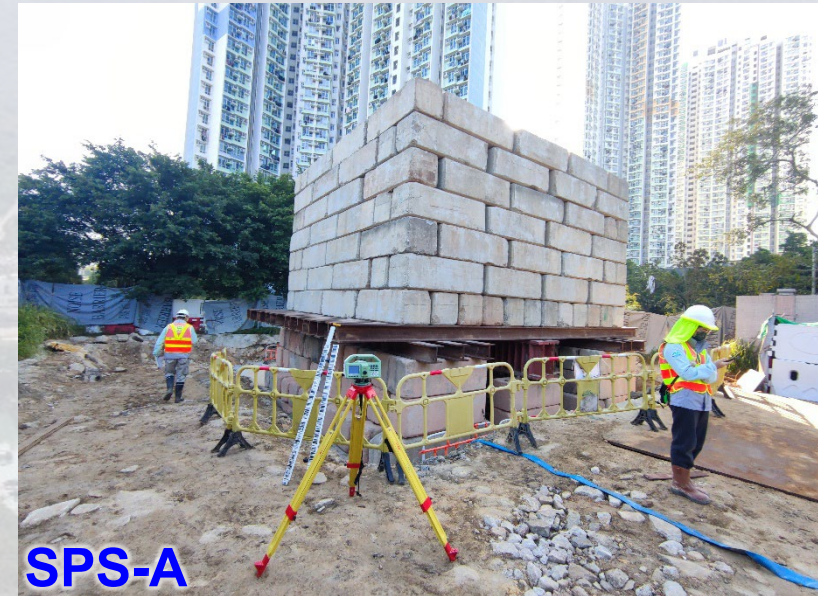
Progress of SPS-A:

1. Piling works completed.
2. Construction of structures of pumping station to be commenced.

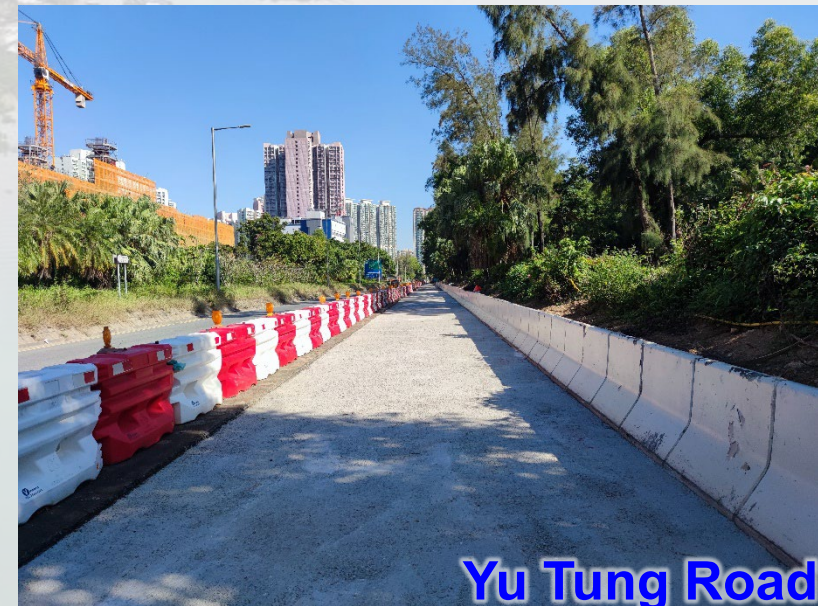
Progress of Yu Tung Road:

1. Construction of underground utilities and road works in progress.

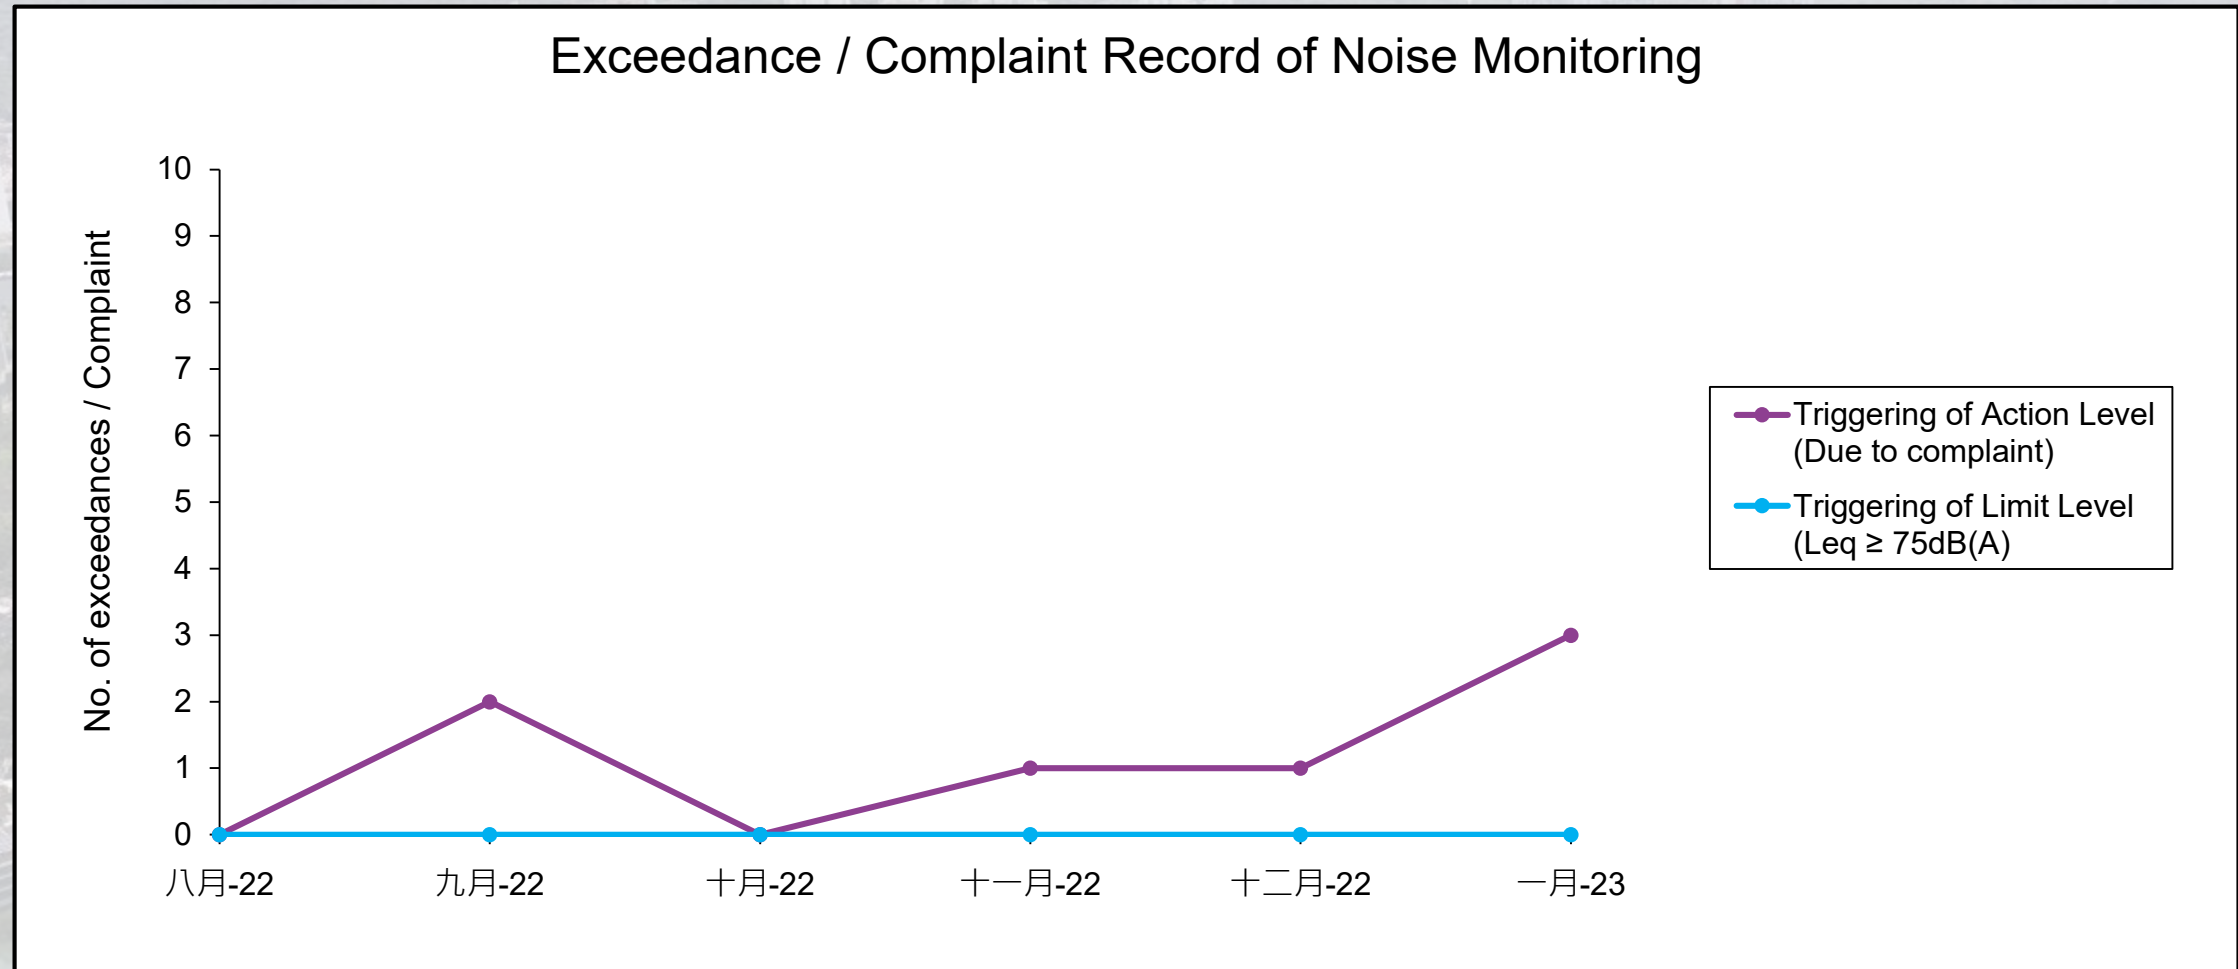
Statistics of Exceedance from Aug 2022 to Jan 2023

Exceedances as recorded in the reporting period were due to the receipt of noise complaints.

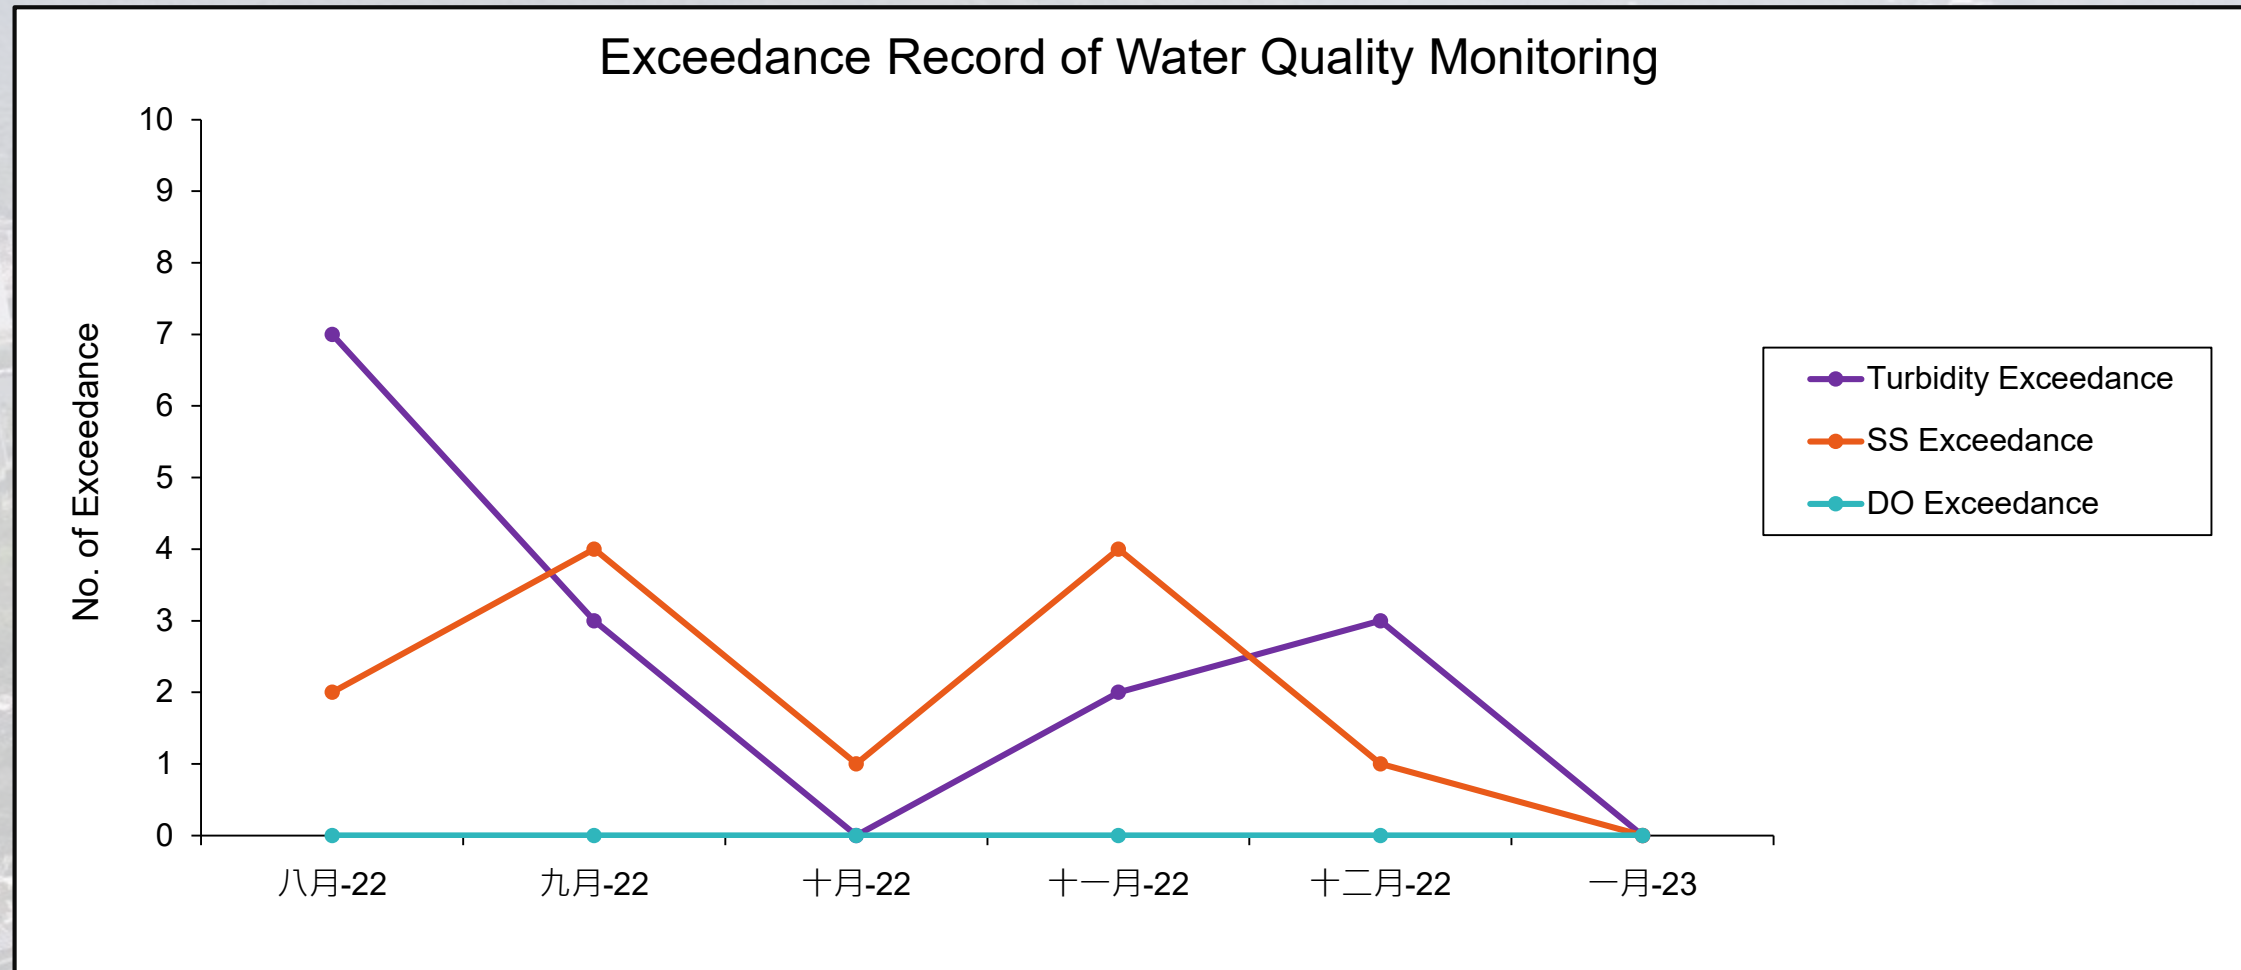
Statistics of Exceedance from Aug 2022 to Jan 2023

Exceedances as recorded in the reporting period were mainly due to inclement weather.
