Tung Chung New Town Extension

9th PLG Meeting
Date : 20 October 2023

土木工程拓展署
CIVIL ENGINEERING AND
DEVELOPMENT DEPARTMENT

可持續大嶼辦事處
SUSTAINABLE LANTAU OFFICE

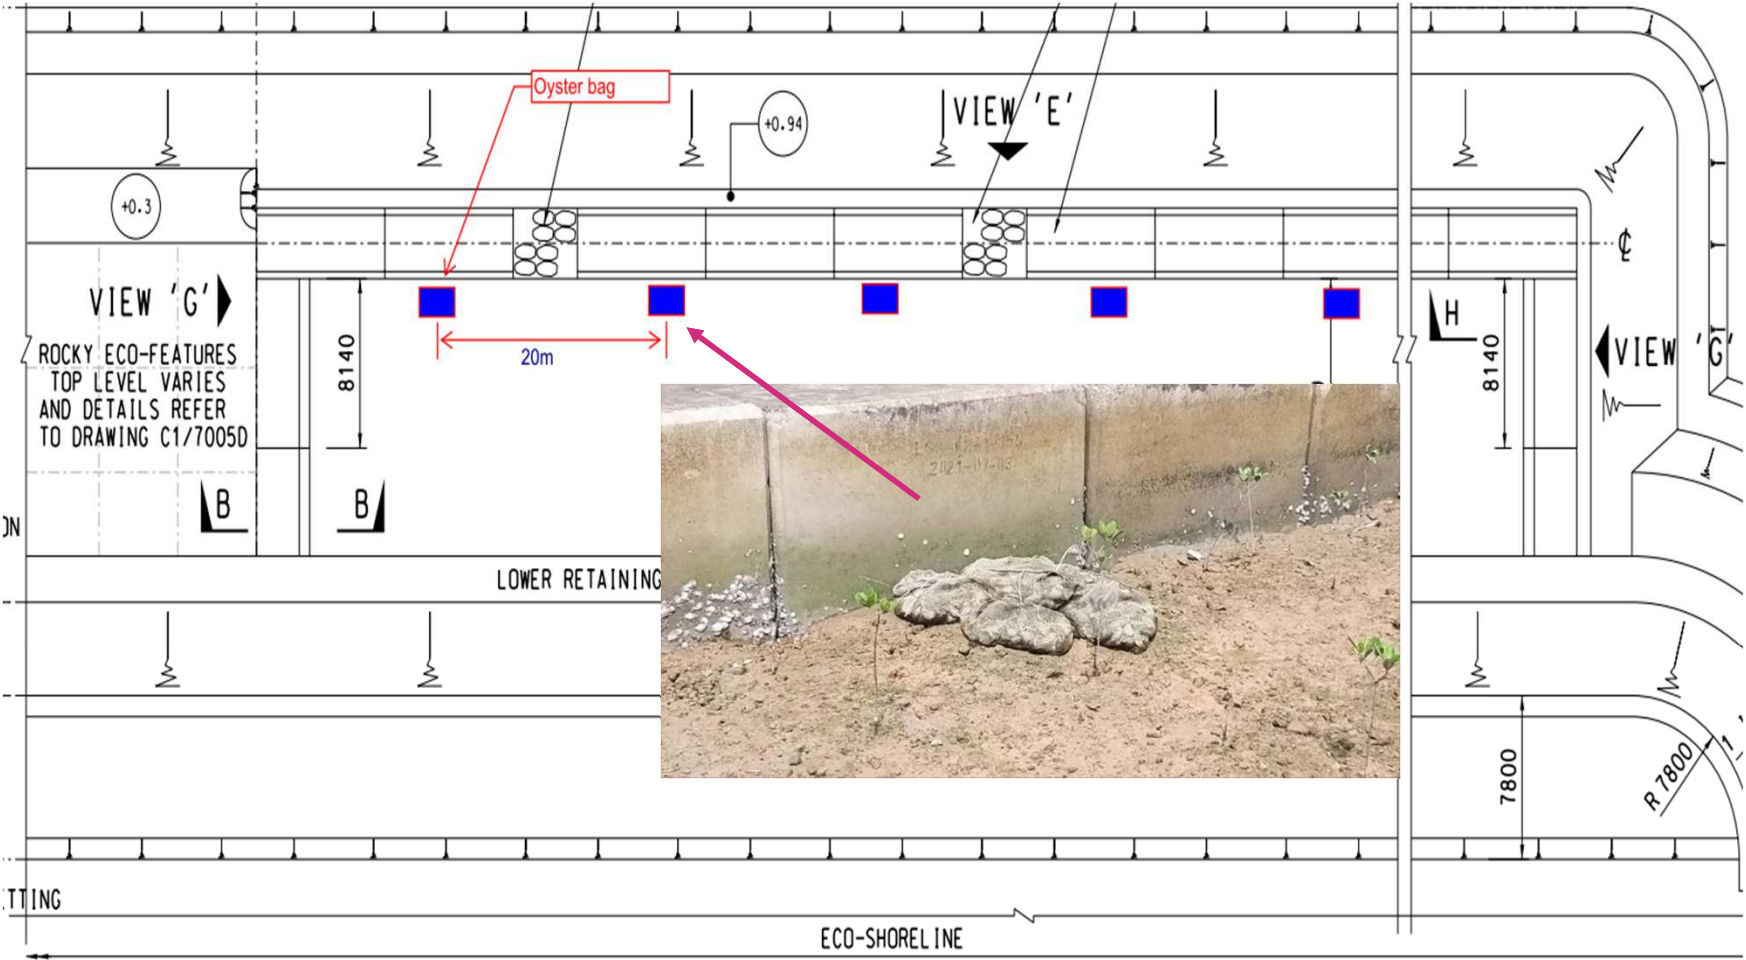
Oyster Bags at Lower Terrace of Mangrove Eco-shoreline

- ❑ S.4.1.4: *“A member suggested to raise the platform level of mangrove eco-shoreline or stock oyster reef at lower platform for more effective ecological enhancement.”*
- Total length of Mangrove Eco-shoreline is 1.2 km
- 1/3 of mangrove area: Platform level has been raised from 0.9mPD to 1.5mPD
- 2/3 of mangrove area: 40 piles of oyster bags (5 oyster bags per pile) will be placed at the lower platform and still in progress.

- 5 oyster bags per pile
- 10mm mesh size nylon net
- 450mm x 600mm each

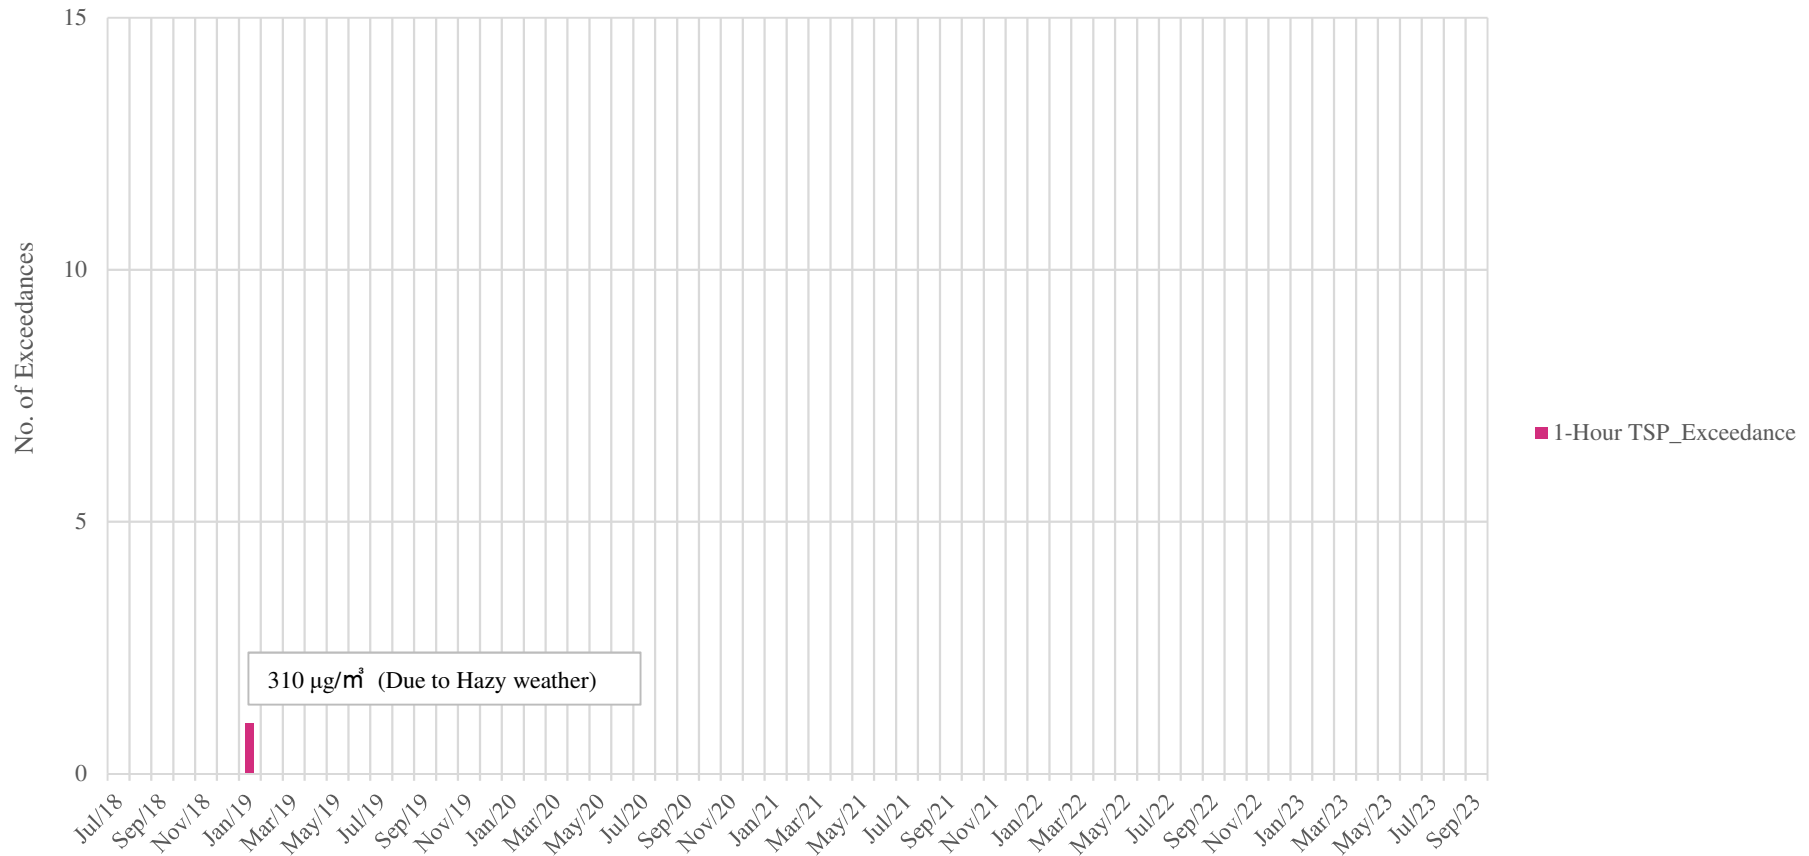
Tung Chung New Town Extension - Reclamation and Advance Works
1-Hour TSP Exceedance Record of Air Quality Monitoring

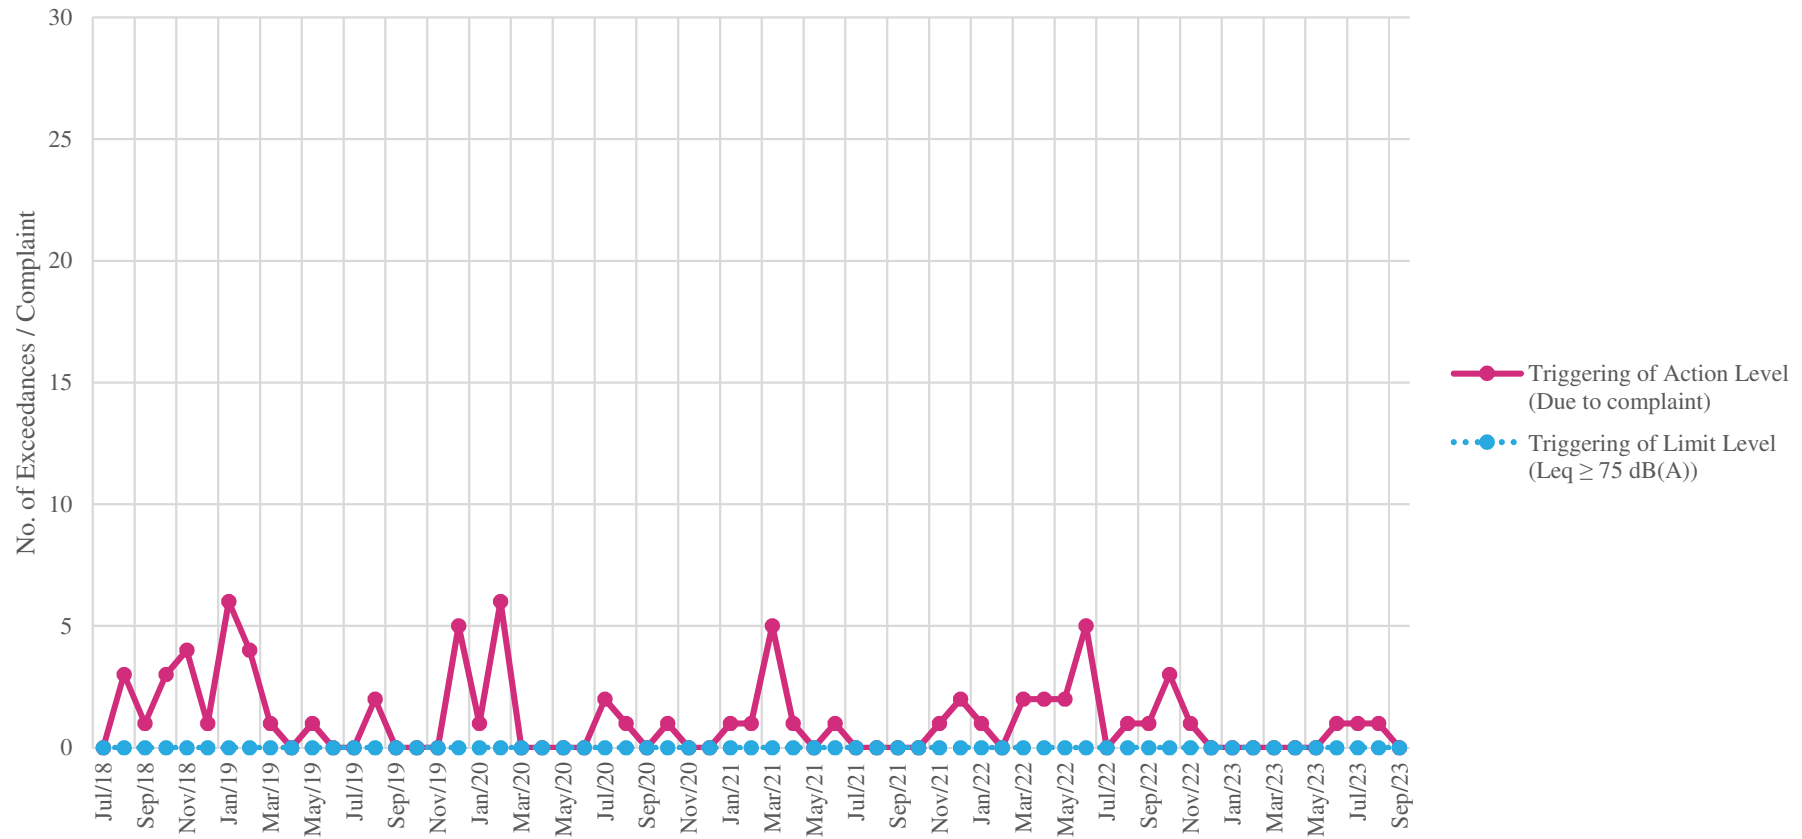
Tung Chung New Town Extension - Reclamation and Advance Works
Exceedance / Complaint Record of Noise Monitoring

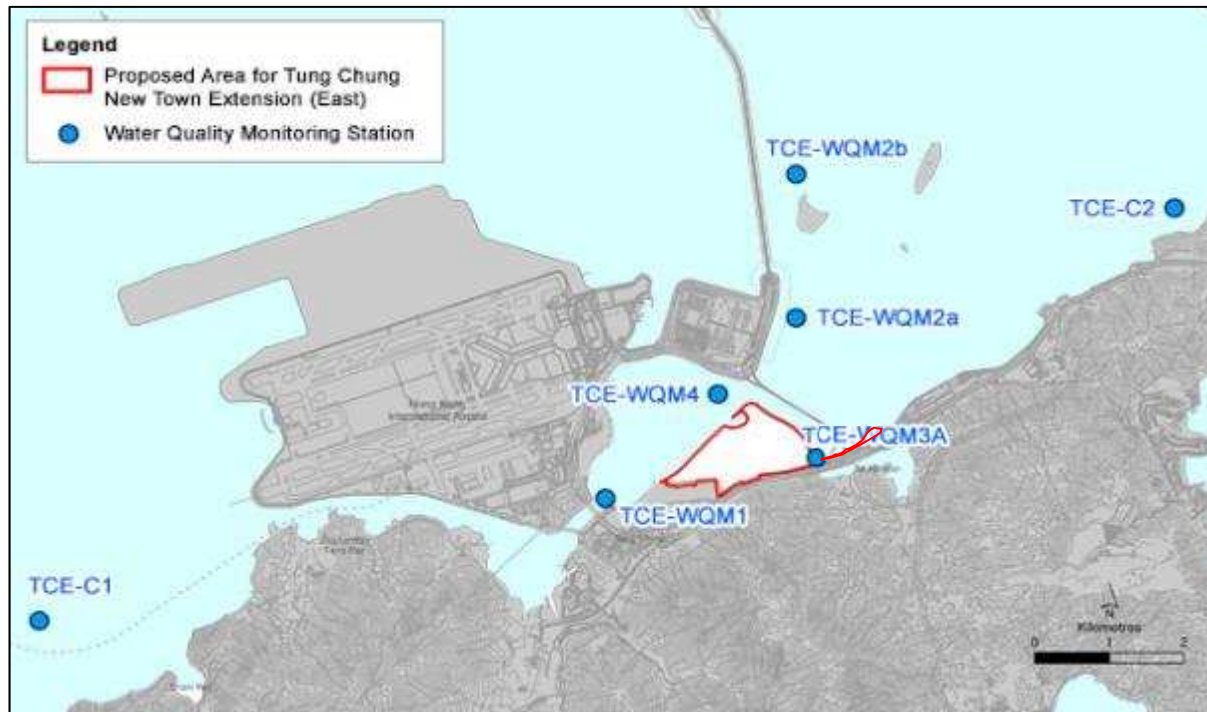
Water Quality Monitoring

Frequency 3 times per week, at mid-flood & mid-ebb tides
Monitoring Parameter Dissolved Oxygen, pH Value, Salinity, Turbidity, Suspended Solids, Temperature

Water monitoring by ET (TCE-WQM4)

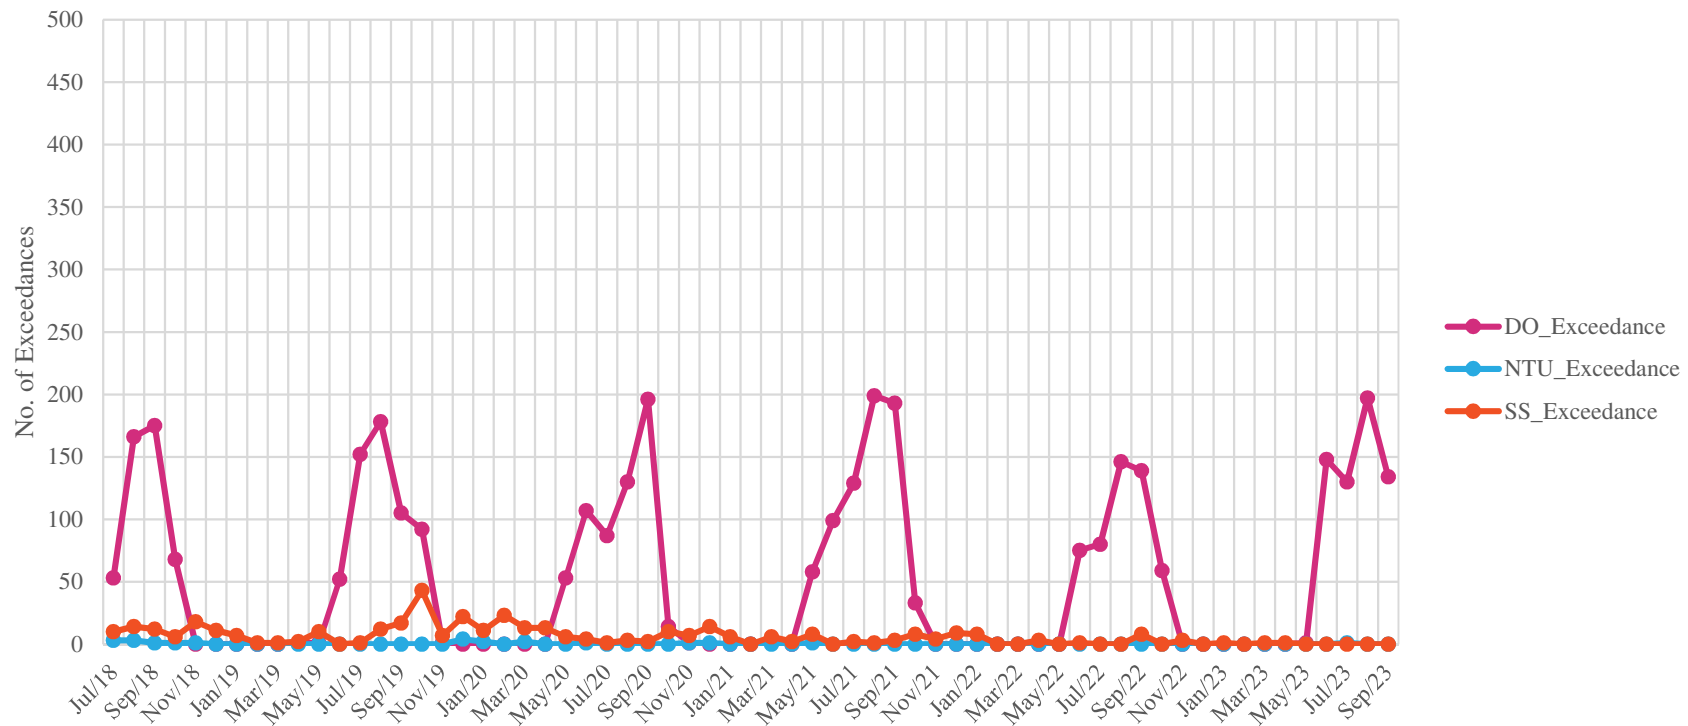
Tung Chung New Town Extension - Reclamation and Advance Works
Exceedance Record of Water Quality Monitoring

The majority exceedances recorded were DO exceedances. Low levels of DO were recorded during summer period. This trend suggested the changes should be due to seasonal fluctuation.

With reclamation and marine construction activities completed, Water Quality Monitoring has been suspended since Oct 2023 with no objections from EPD.

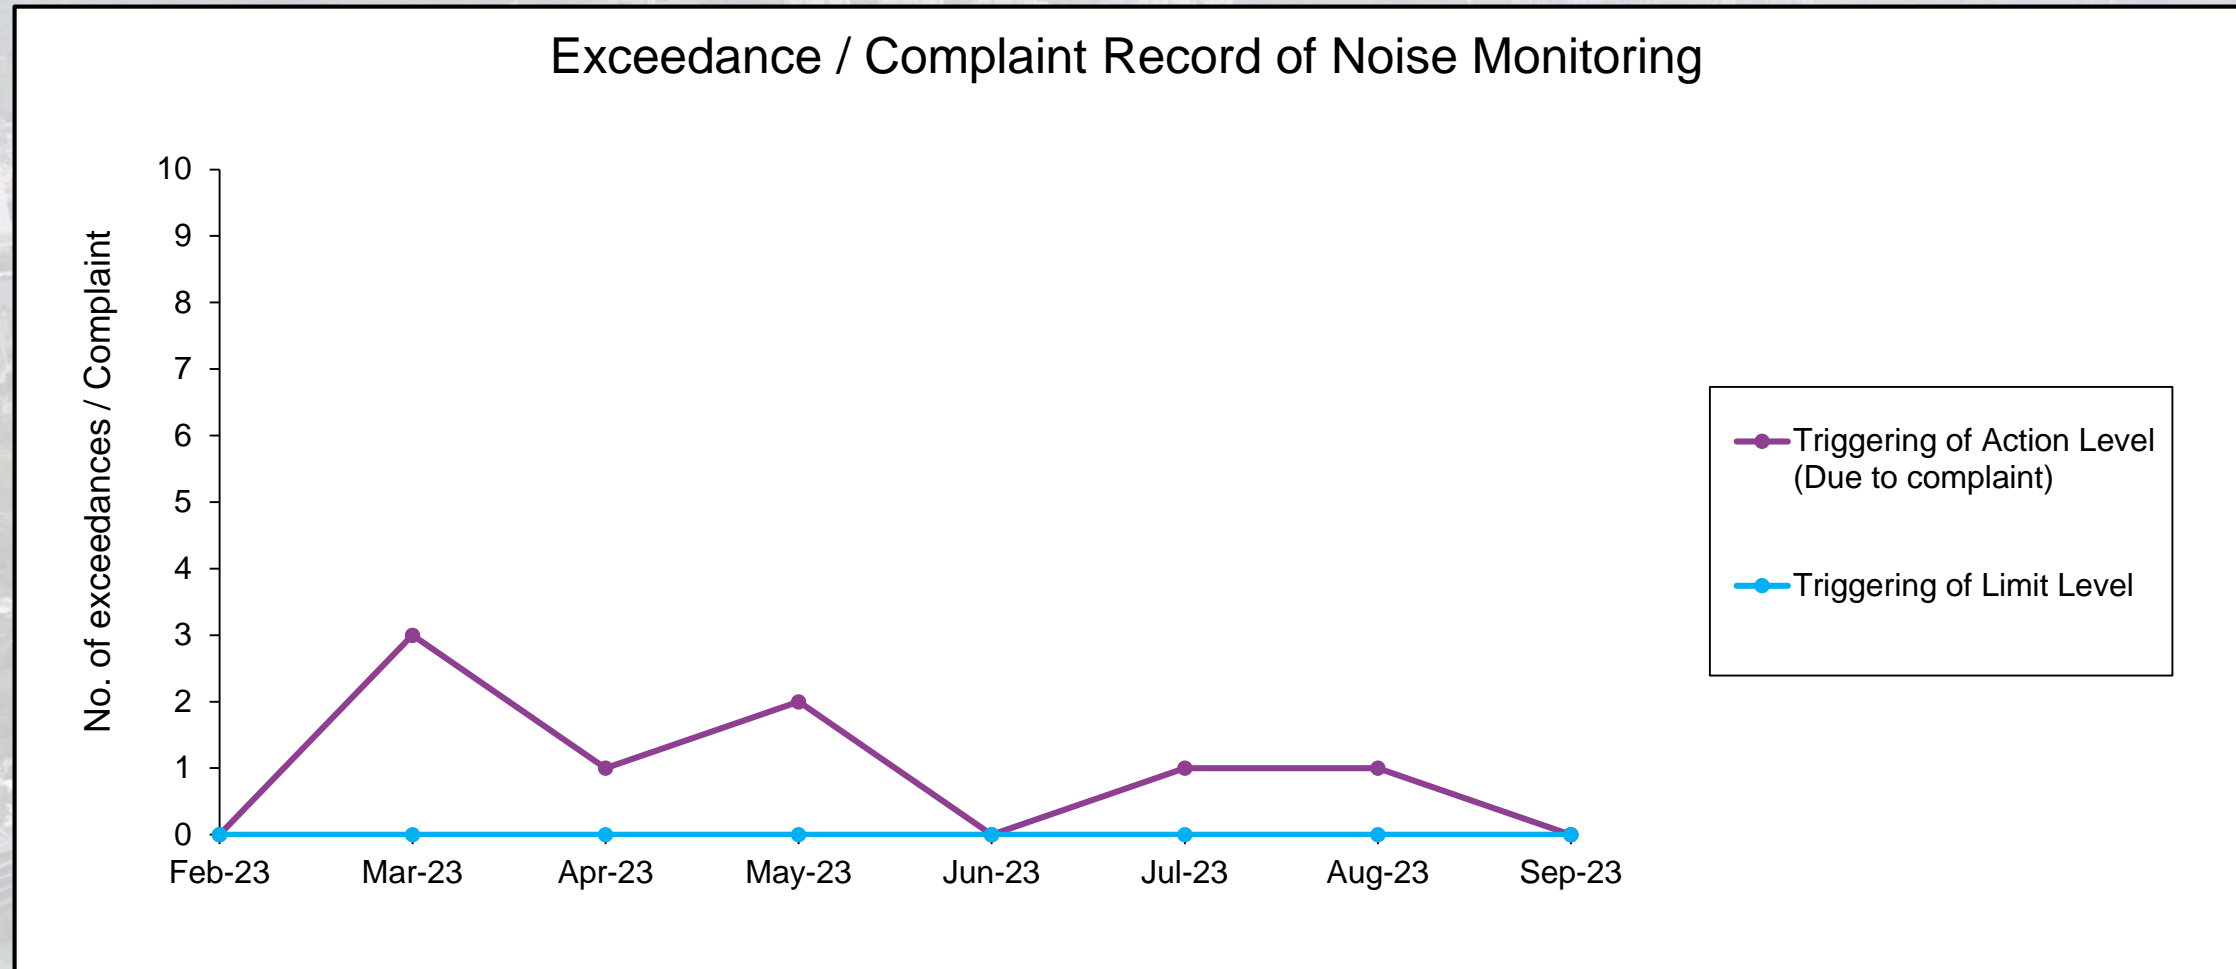
Statistics of Exceedance from Feb 2023 to Sep 2023

Exceedances as recorded in the reporting period were due to the receipt of noise complaints.

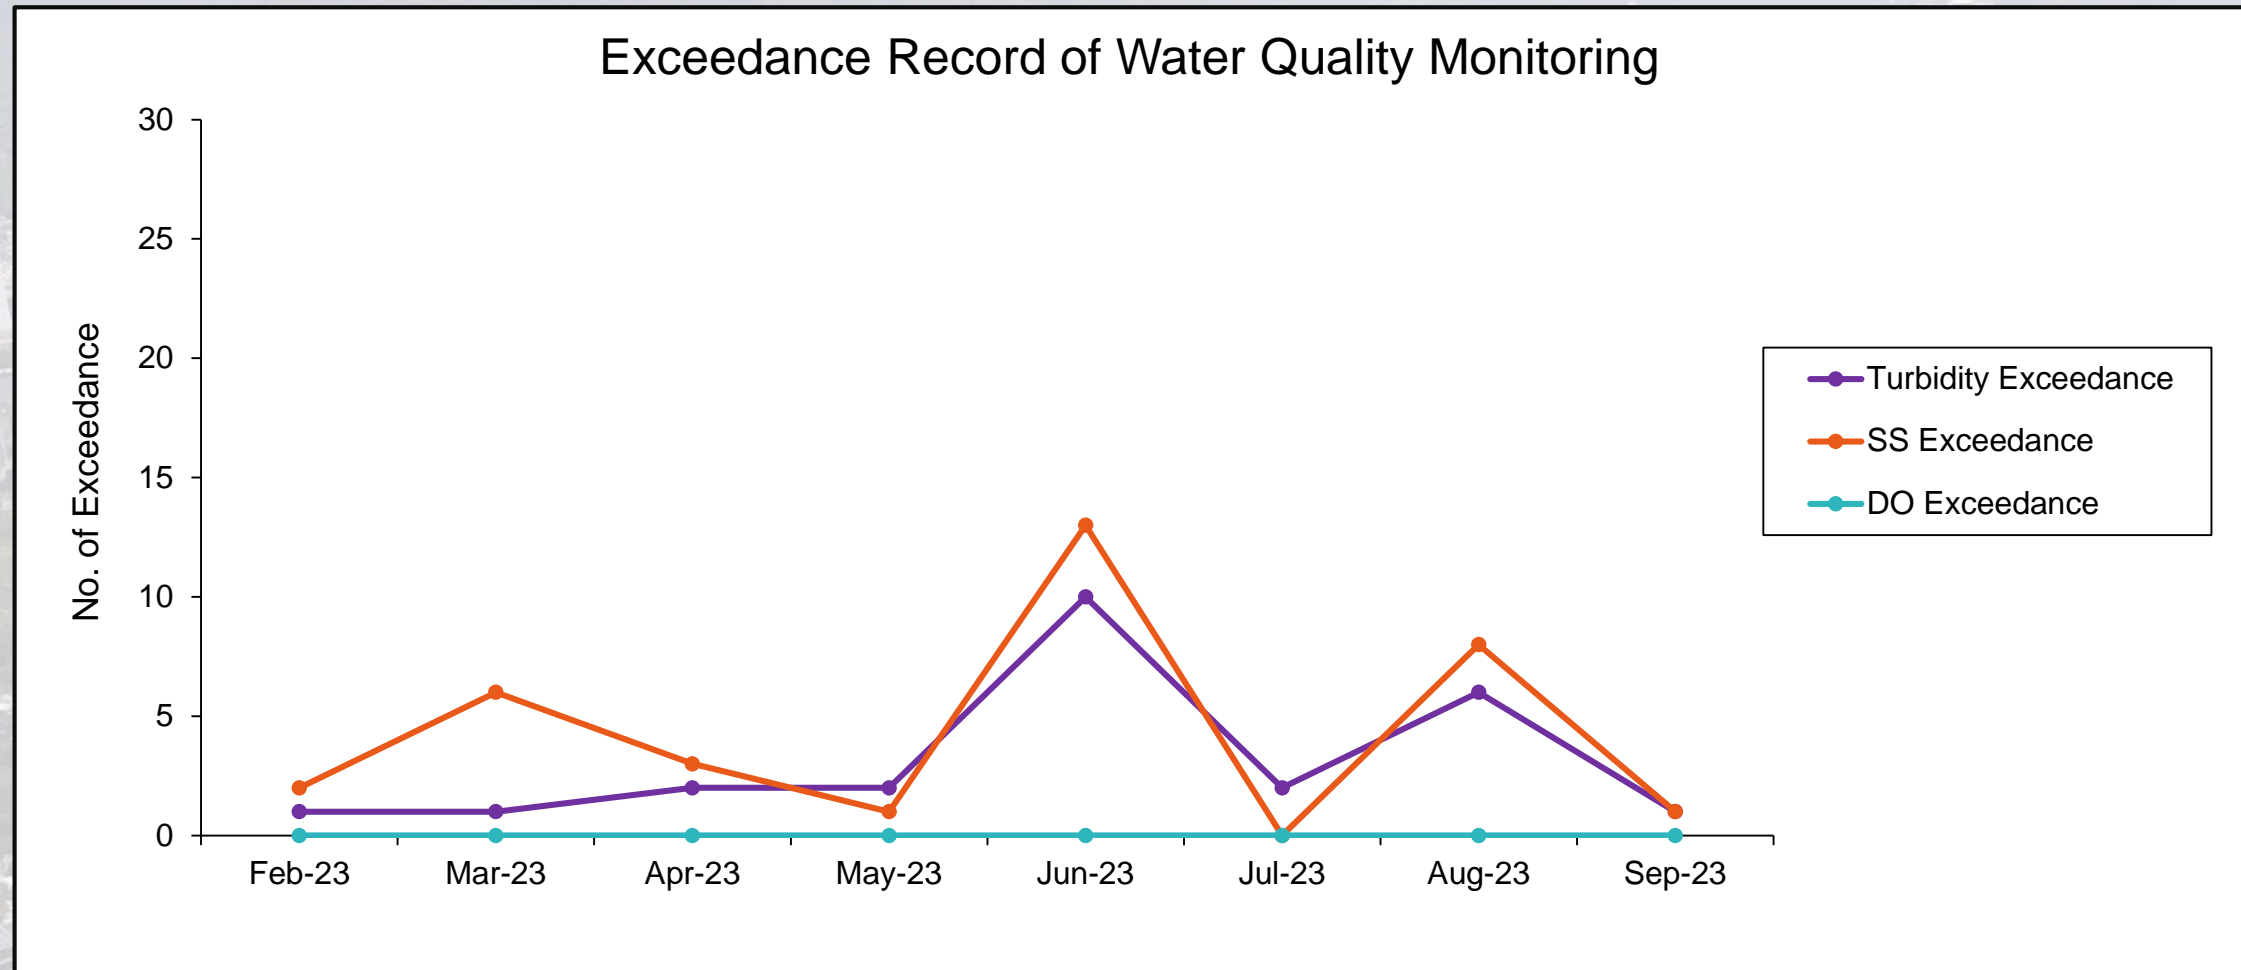
Statistics of Exceedance from Feb 2023 to Sep 2023

1. Impact monitoring is carried out at seven stations for three times per week.
2. Exceedances as recorded in the reporting period were mainly due to the inclement weather.

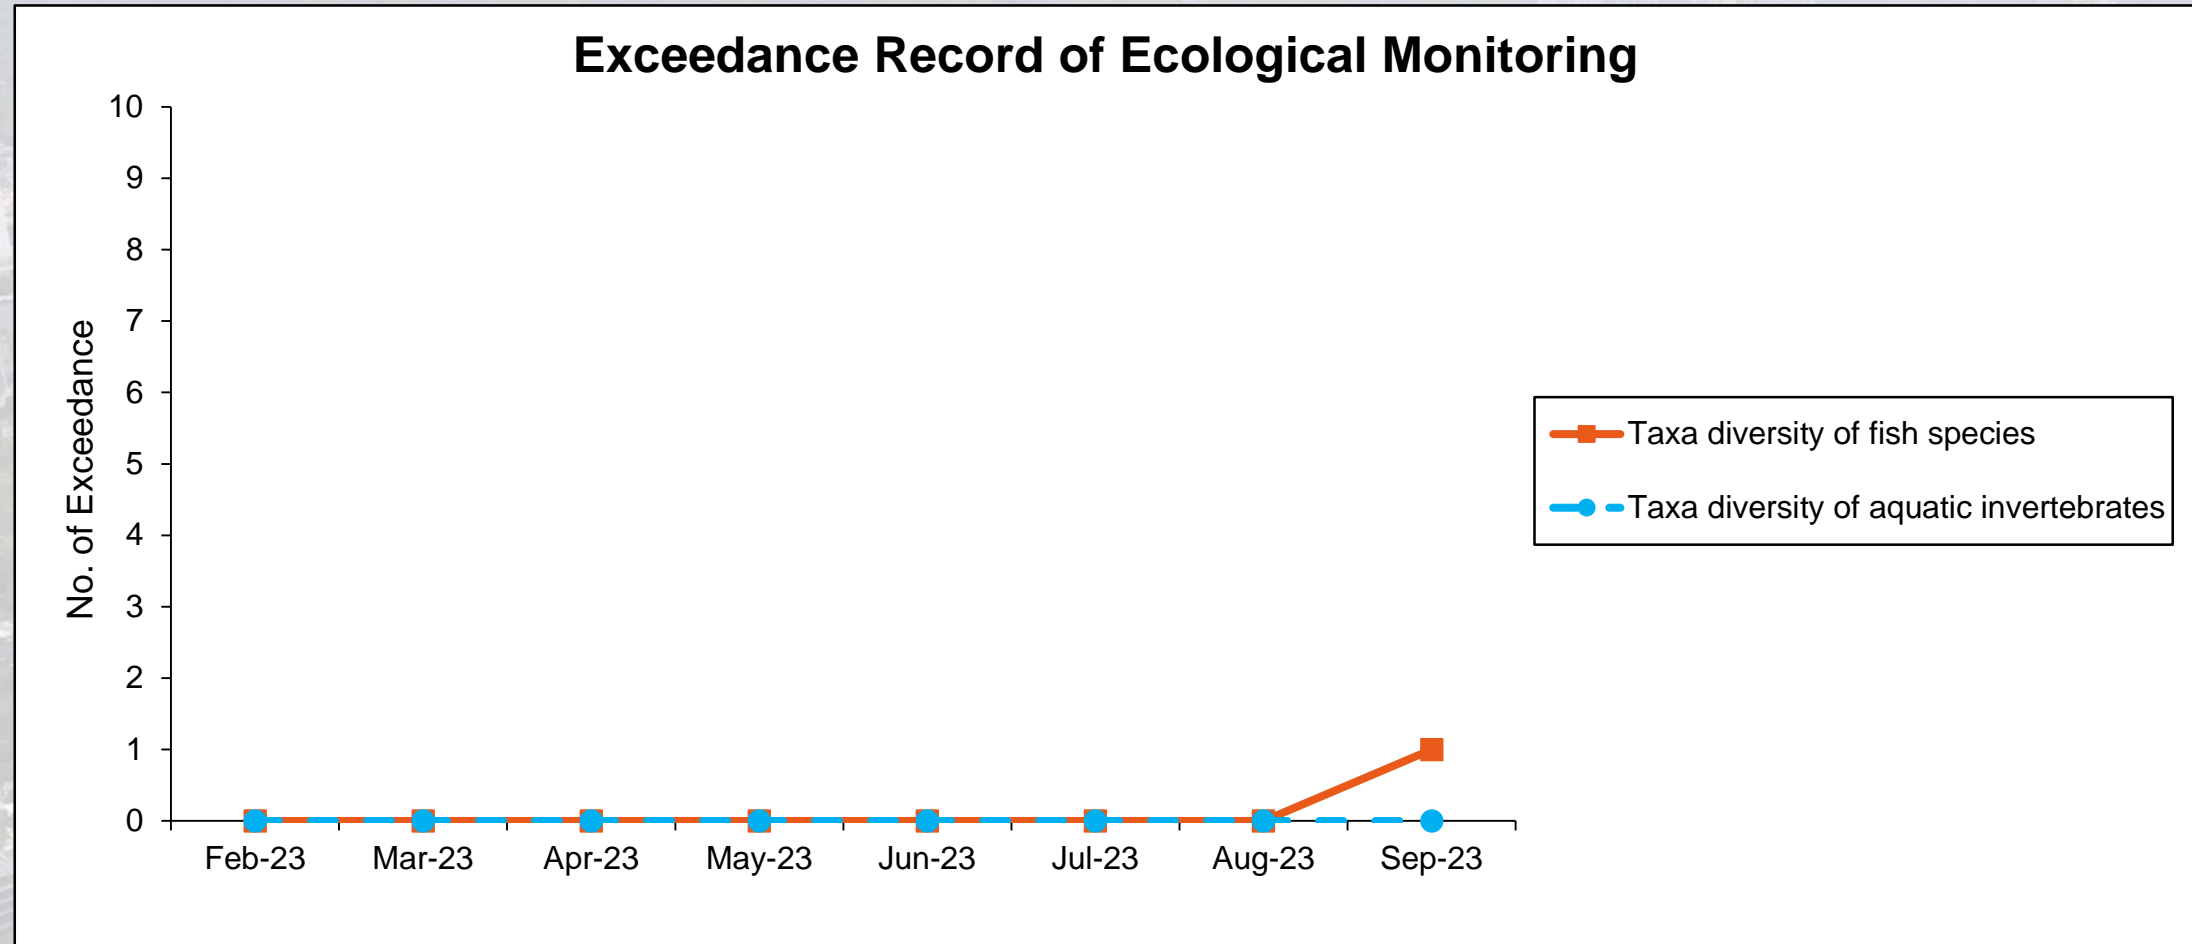
Statistics of Exceedance from Feb 2023 to Sep 2023

1. Exceedance as recorded in the reporting period was mainly due to extreme weather and consecutive heavy rainfall.
