Agreement No. CE 60/2017 (EP)

Environmental Team for Tung Chung New Town Extension (East) - Design and Construction

Monthly Environmental Monitoring & Audit Report for August 2023

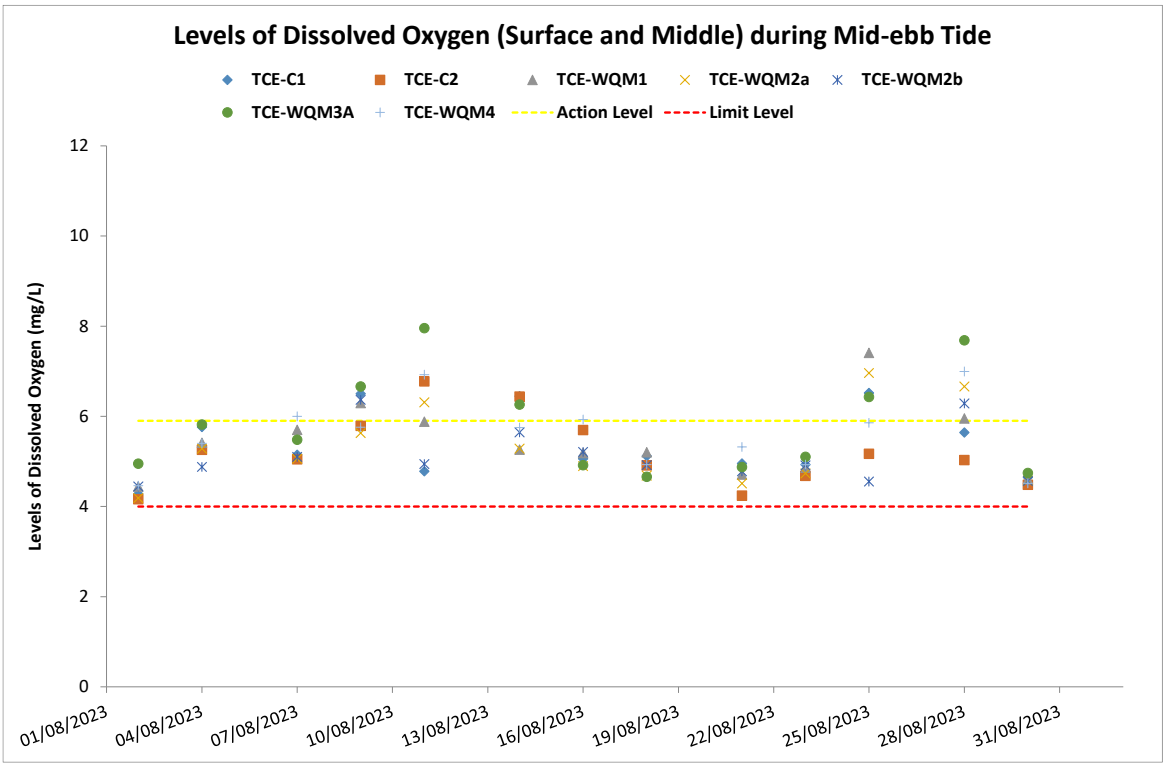
Based on the investigation conducted for each of the monitoring day with exceedance, the exceedances of DO were not likely caused by the work activities related to the Project.

In addition, low levels of DO were recorded during previous three summer periods. This further suggested that exceedances of DO are likely caused by seasonal fluctuation and a similar trend of lower levels of DO would likely occur again during this summer period.

Figure 1: Levels of Dissolved Oxygen (Surface and Middle) (mg/L) recorded at Mid-ebb Tide during the Water Quality Monitoring between 1 to 31 August 2023

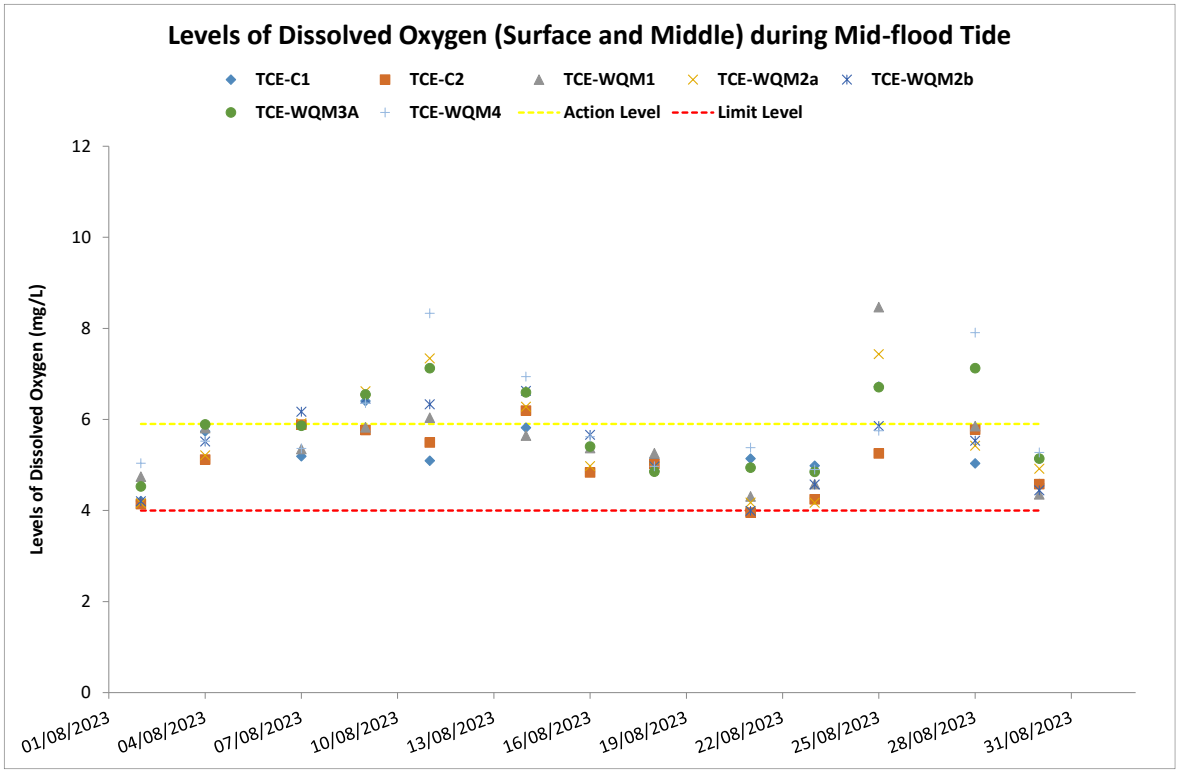
Figure 2: Levels of Dissolved Oxygen (Surface and Middle) (mg/L) recorded at Mid-flood Tide during the Water Quality Monitoring between 1 to 31 August 2023

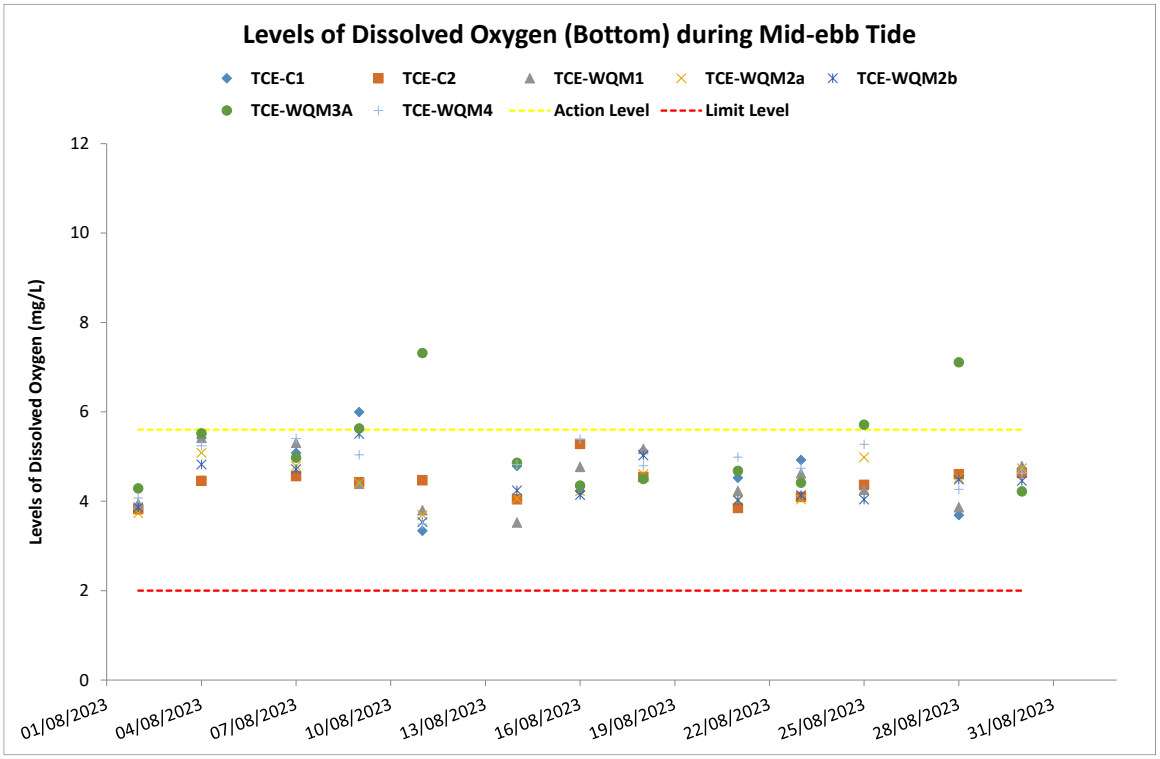
Figure 3: Levels of Dissolved Oxygen (Bottom) (mg/L) recorded at Mid-ebb Tide during the Water Quality Monitoring between 1 to 31 August 2023

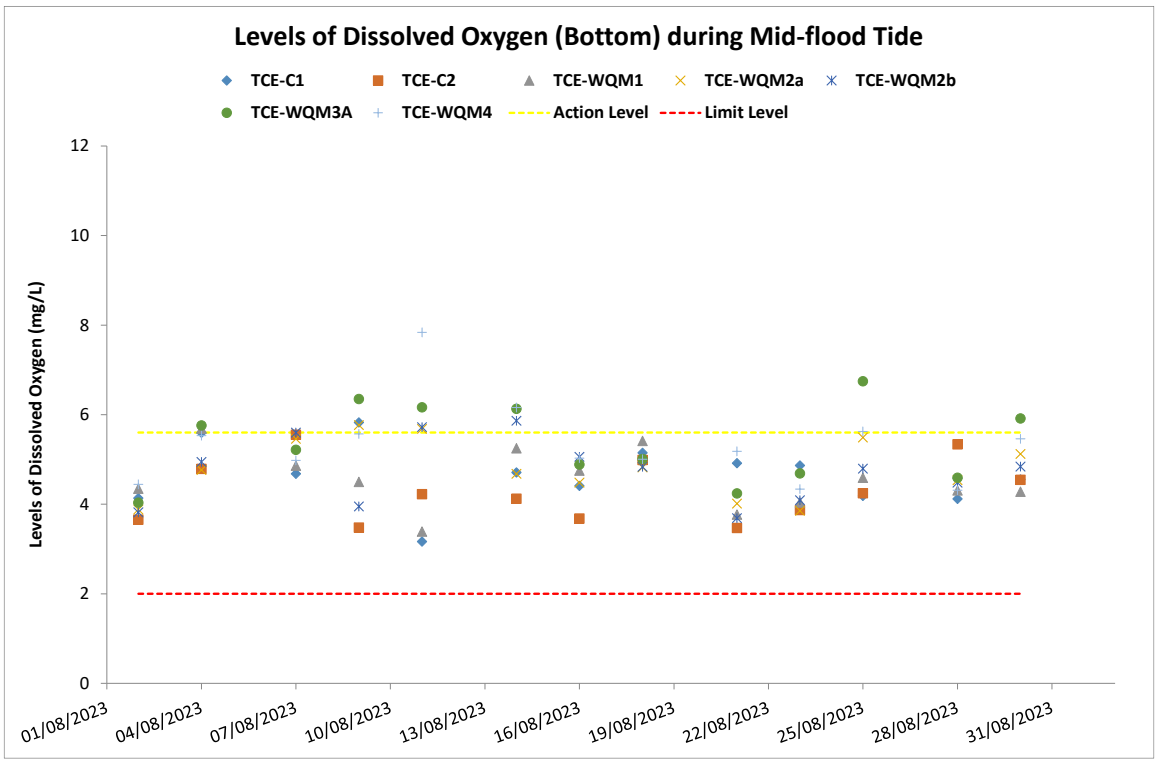
Figure 4: Levels of Dissolved Oxygen (Bottom) (mg/L) recorded at Mid-flood Tide during the Water Quality Monitoring between 1 to 31 August 2023

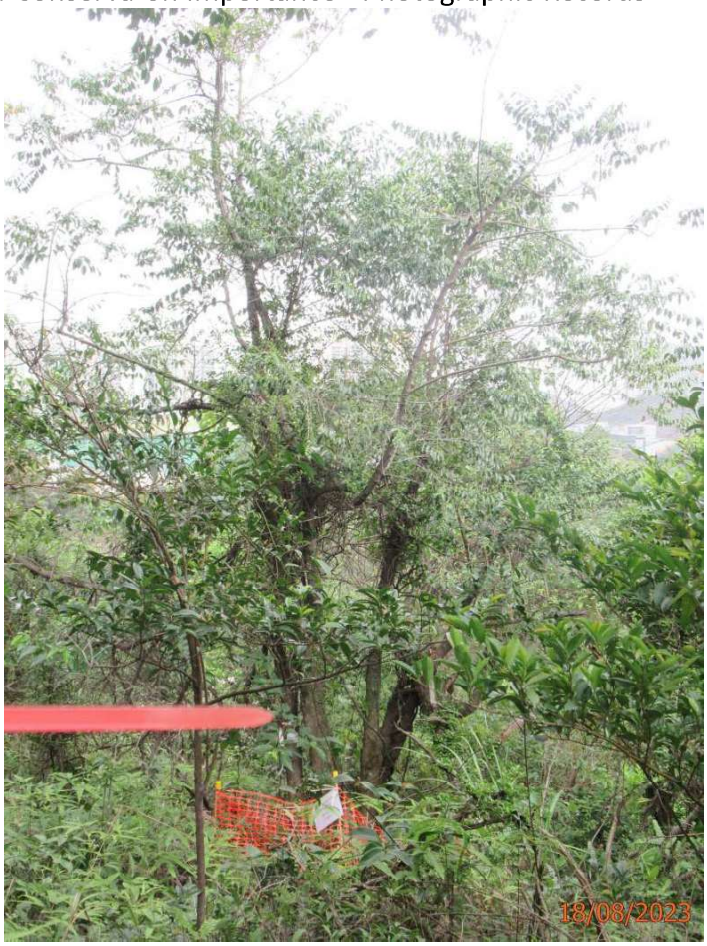
G04_83_84_85-R04 (T1788)

Monthly monitoring of the *in-situ* preserved plant species of conservation importance by the Qualified Personnel (QP) appointed under Contract 2 was implemented in the reporting period. Health condition was considered fair for the majority of the *in-situ* preserved plant species of conservation importance, of which two individuals of *Gmelina chinensis* could not be monitored as a result of unsafe access to the locations, as recorded during the monitoring carried out on 18 August 2023.

Tree protection zones for the *in-situ* preserved plant species of conservation importance were demarcated. No injuries and/or damages to the individuals of the *in-situ* preserved plant species of conservation importance

Contract No.: NL/2020/02
Tung Chung New Town Extension - Salt Water Supply System
Monthly Report (18 August 2023) In-situ Plant Species of Conserva-on Importance - Photographic Records
