Agreement No. CE 60/2017 (EP)

## **Environmental Team for Tung Chung New Town Extension (East) - Design and Construction**

Monthly Environmental Monitoring & Audit Report for July 2022

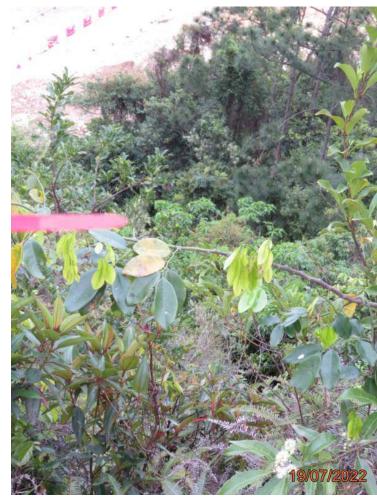
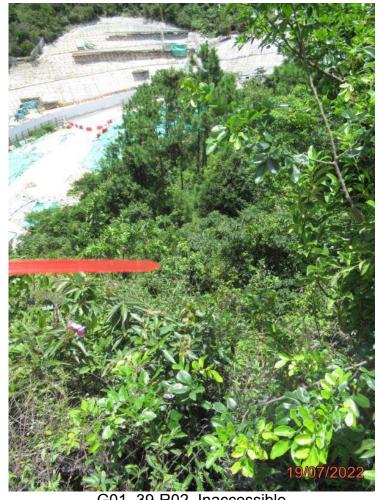
monitored as a result of unsafe access to the locations, as recorded during the monitoring carried out on 19 July 2022.

G01\_39-R01\_Inaccessible

G01\_39-R02\_Inaccessible
