Agreement No. CE 60/2017 (EP)

Environmental Team for Tung Chung New Town Extension (East) - Design and Construction

**Monthly Environmental Monitoring & Audit Report
for March 2023**

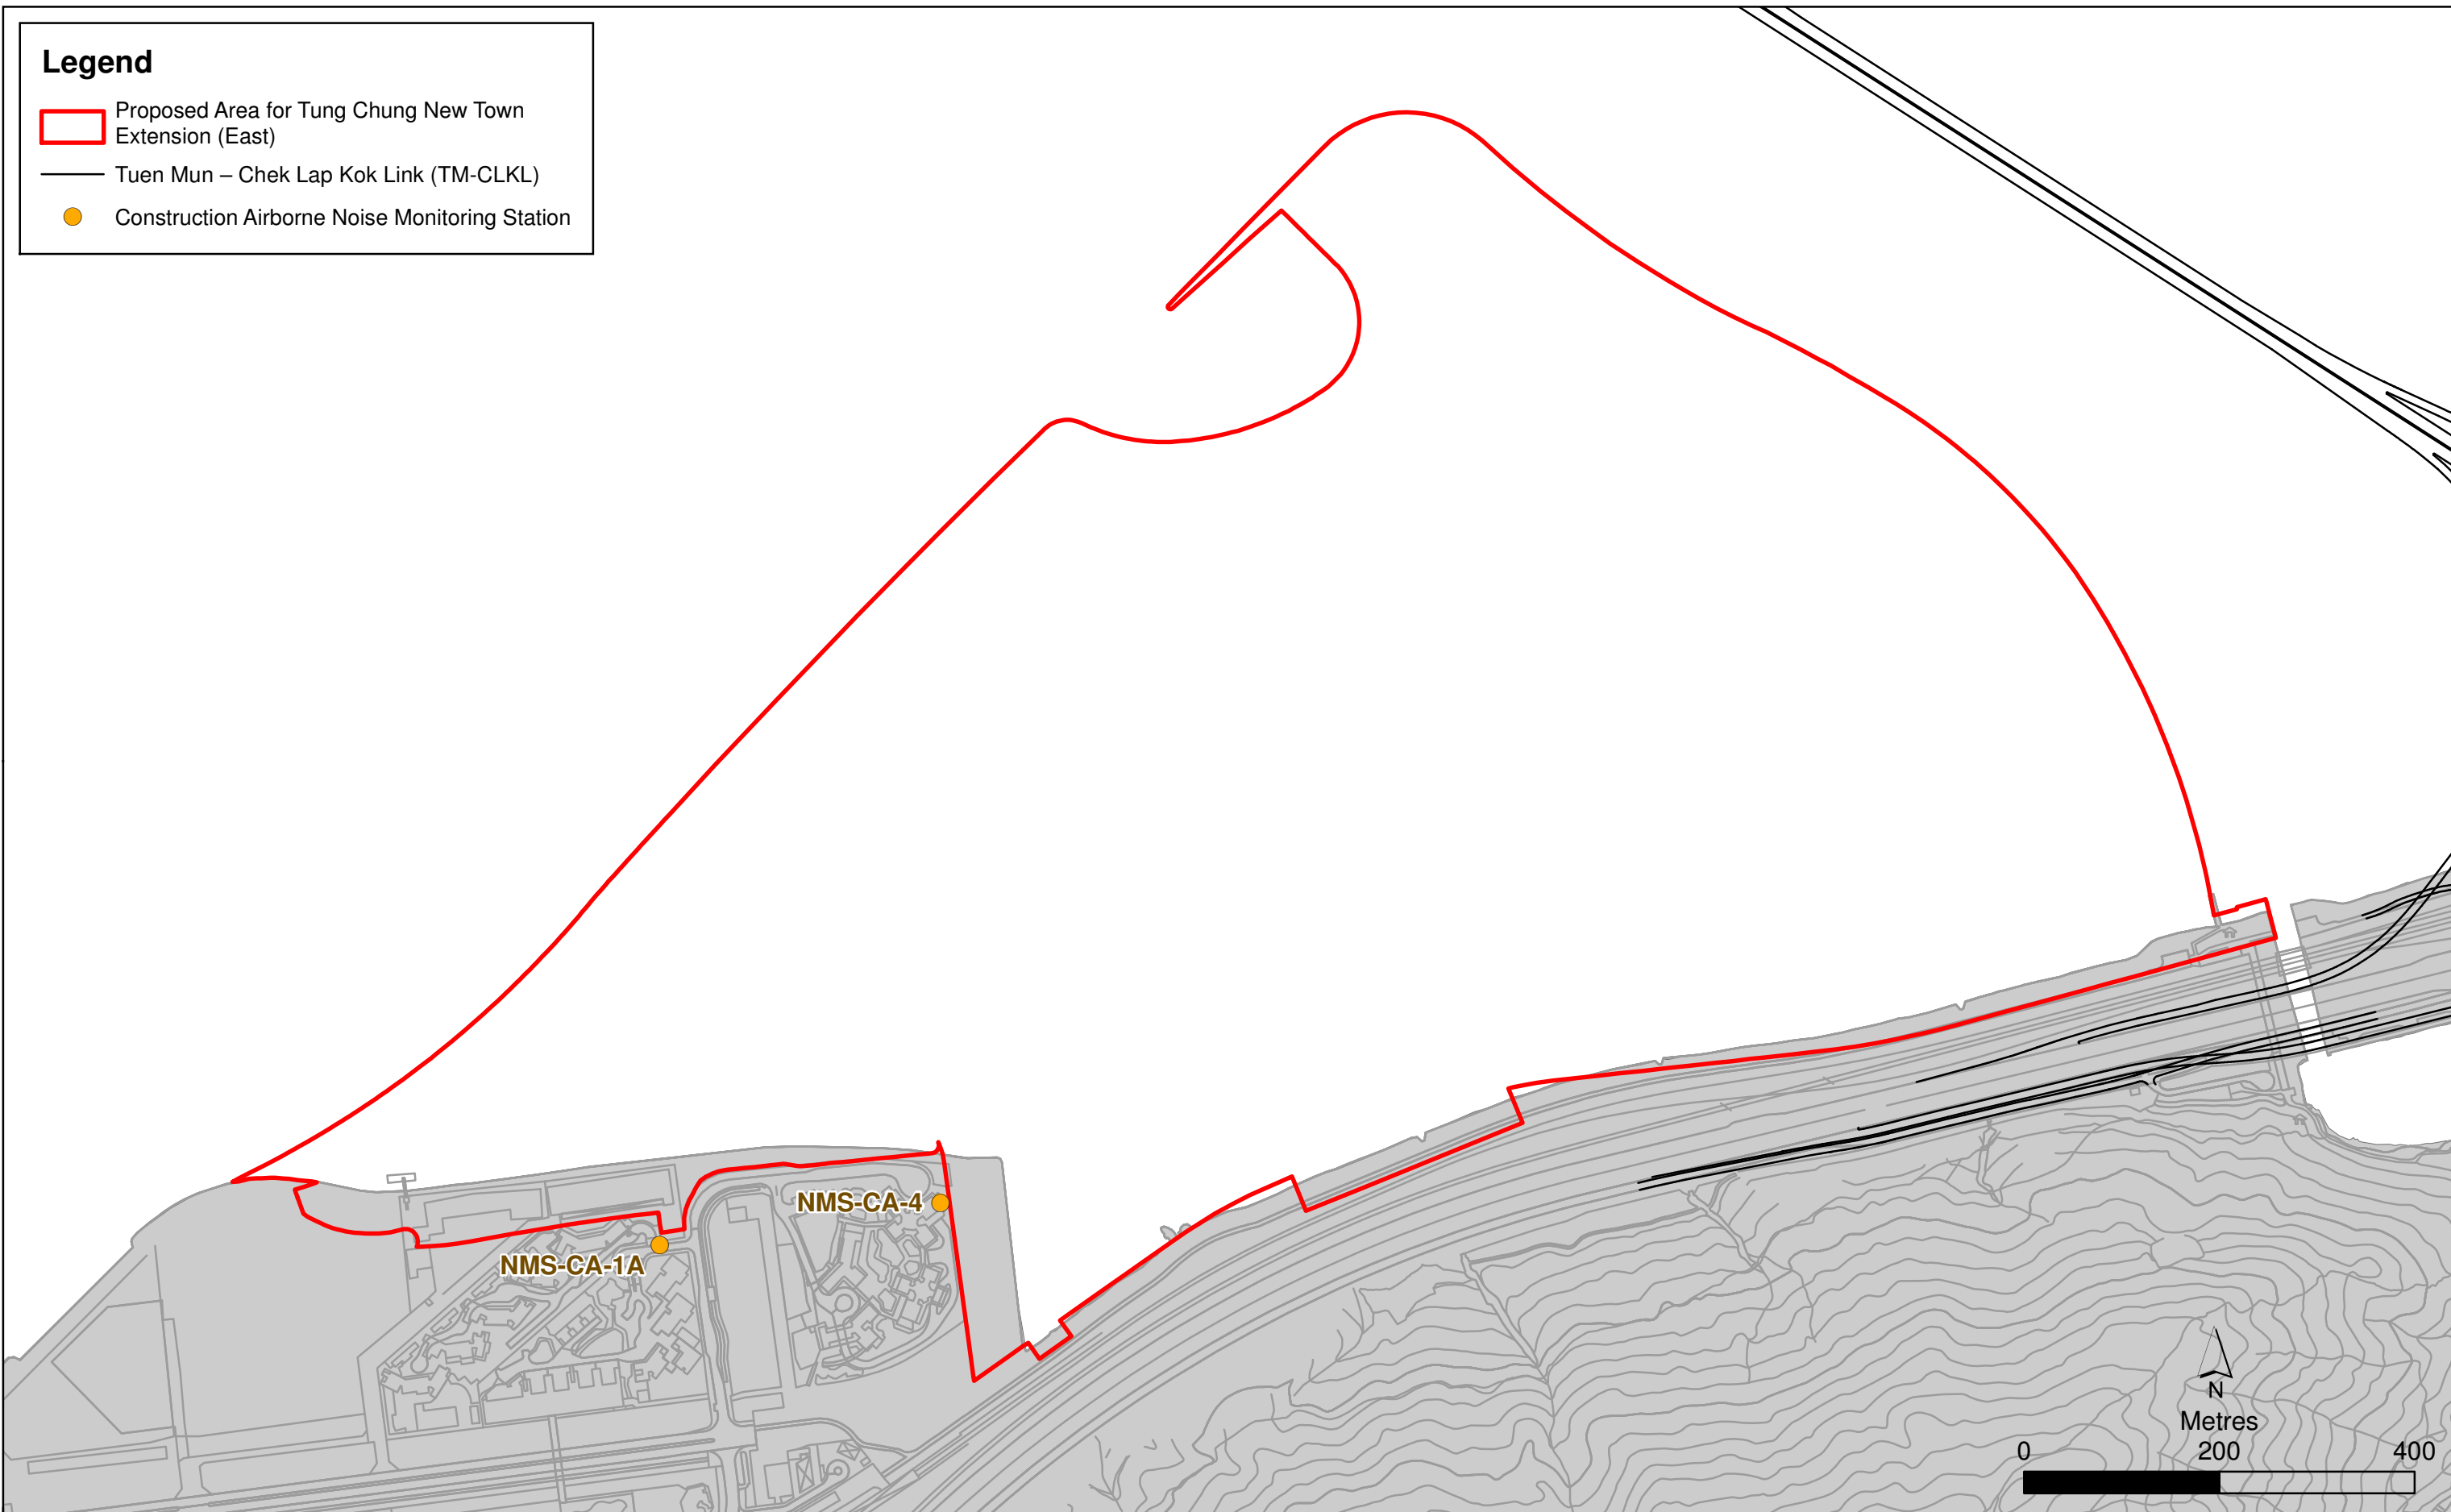
Figure 2.2

(2) Due to land handover issue, NMS-CA-1A was relocated to Ying Hong Road which is located 60m away from the original location. Proposal on the relocation of NMS-CA-1A was approved by IEC on 23 November 2018. Noise monitoring at the relocated location commenced since 24 November 2018.

Construction Airborne Noise Monitoring Station Location

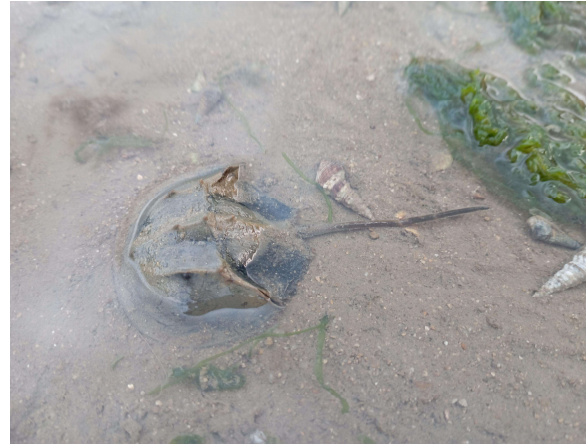
(e) Horseshoe crabs *Tachypleus tridentatus* recorded at TCB3 during the Qualitative Walk-through Survey

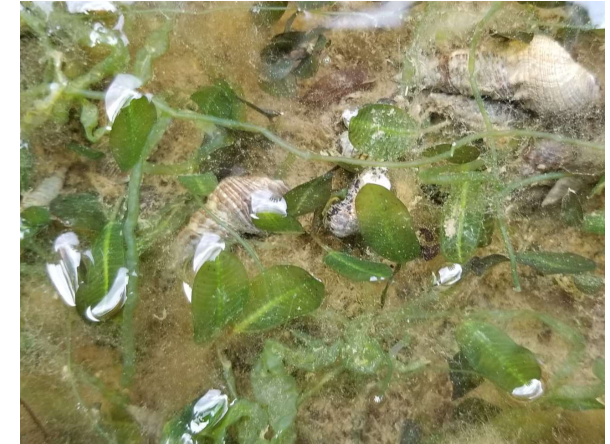
(f) Seagrass *Halophila ovalis* recorded at TCB3 during the Qualitative Walk-through Survey

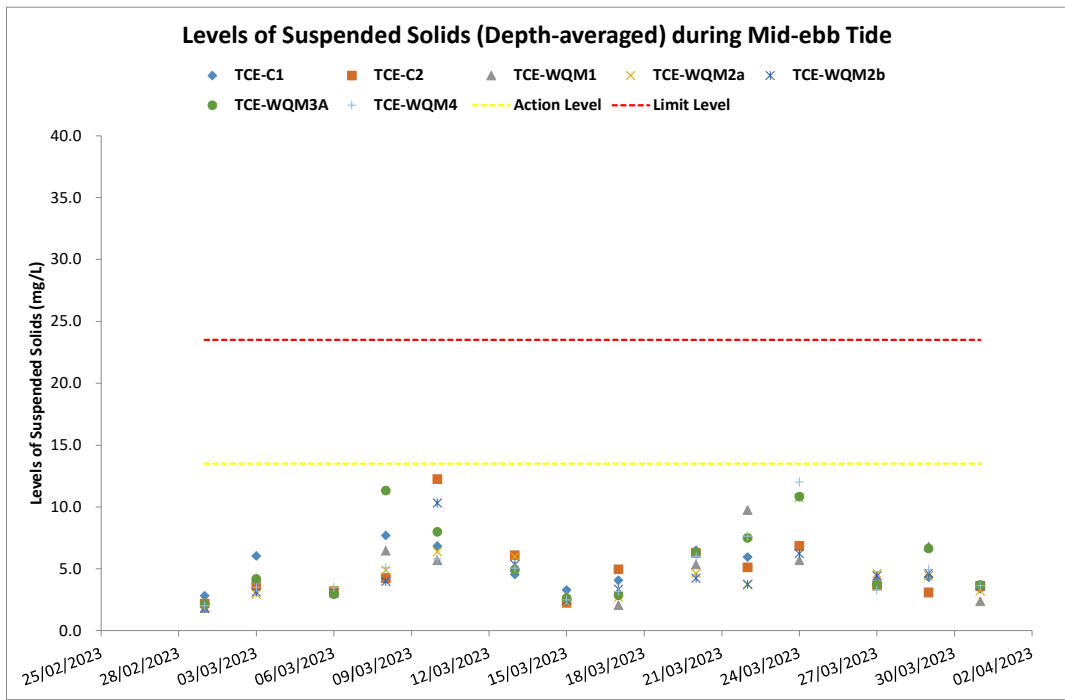
Figure 7: Levels of Suspended Solids (Depth-averaged) (mg/L) recorded at Mid-ebb Tide during the Water Quality Monitoring between 1 to 31 March 2023

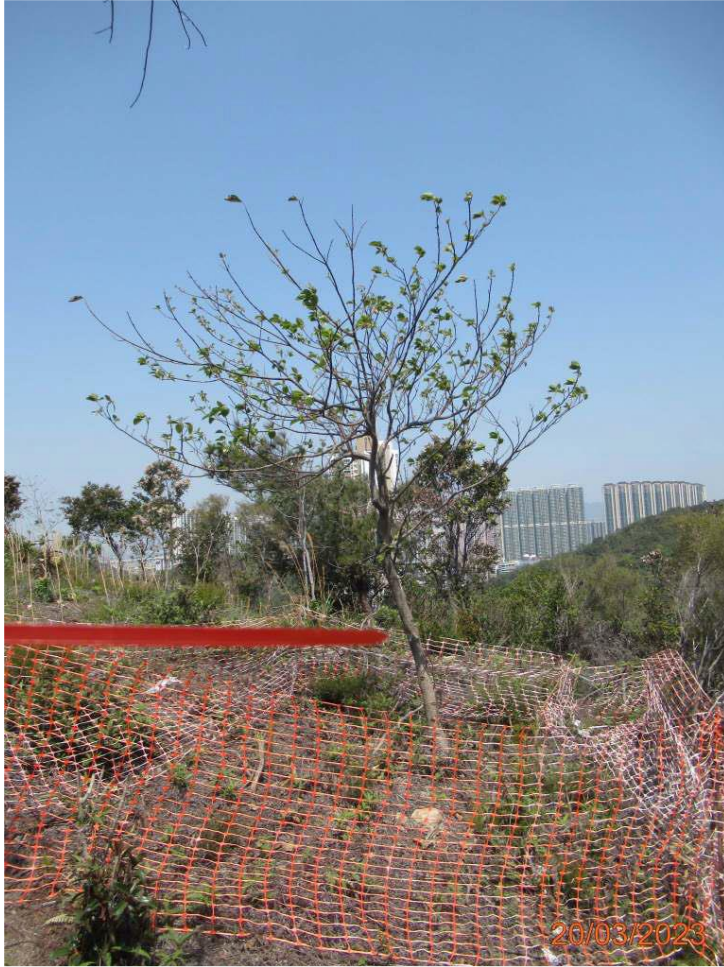
Photo 1 - Tree protection zone for preserved plant species of conservation importance

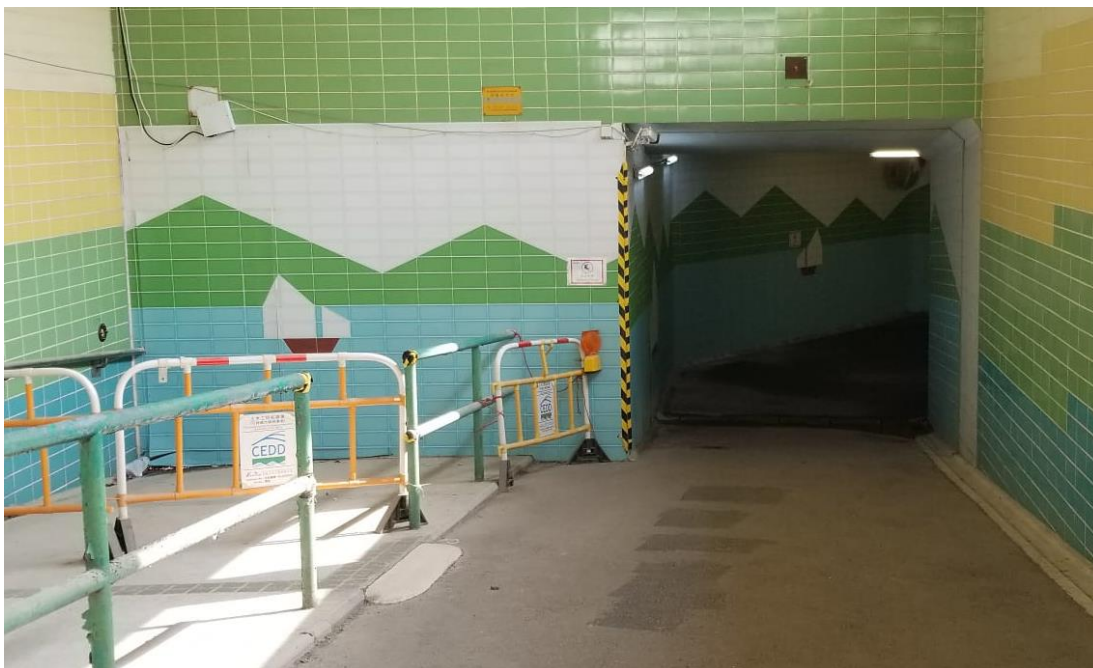
Photo 3 - Erection of site hoardings in unobtrusive colours

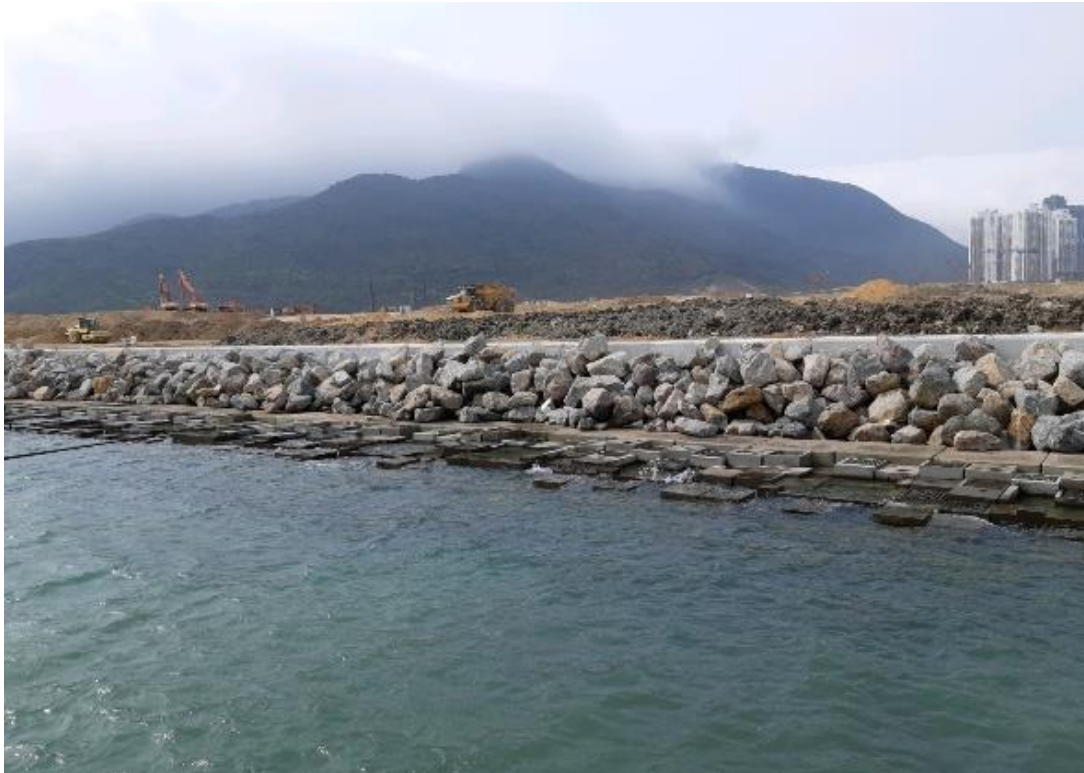
Photo 4 - Natural Rock Material/Planting for Artificial Seawall
