Agreement No. CE 60/2017 (EP)

Environmental Team for Tung Chung New Town Extension (East) - Design and Construction

Monthly Environmental Monitoring & Audit Report for May 2023

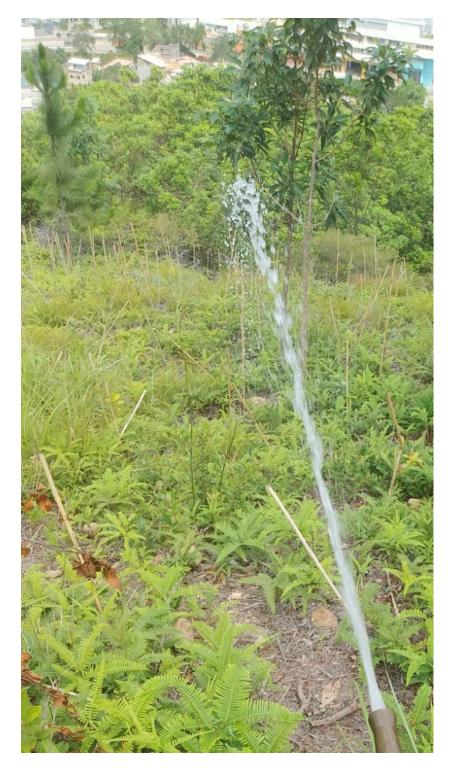
Photo 1 – General view of compensation woodland in Portion 1 $\,$

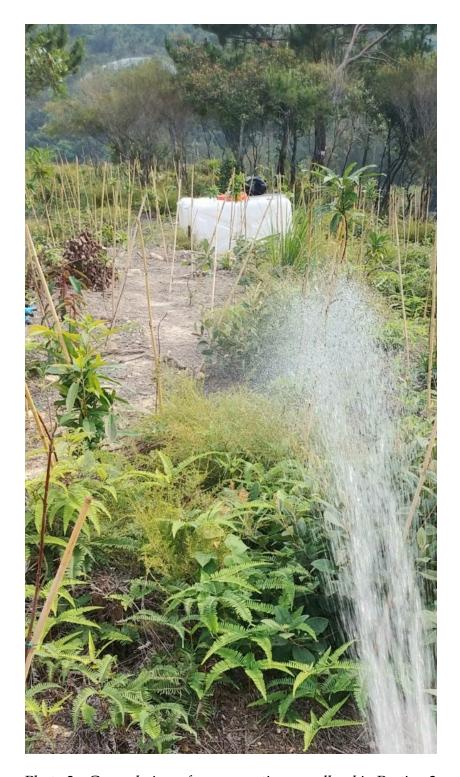
Photo 2 – General view of compensation woodland in Portion 2

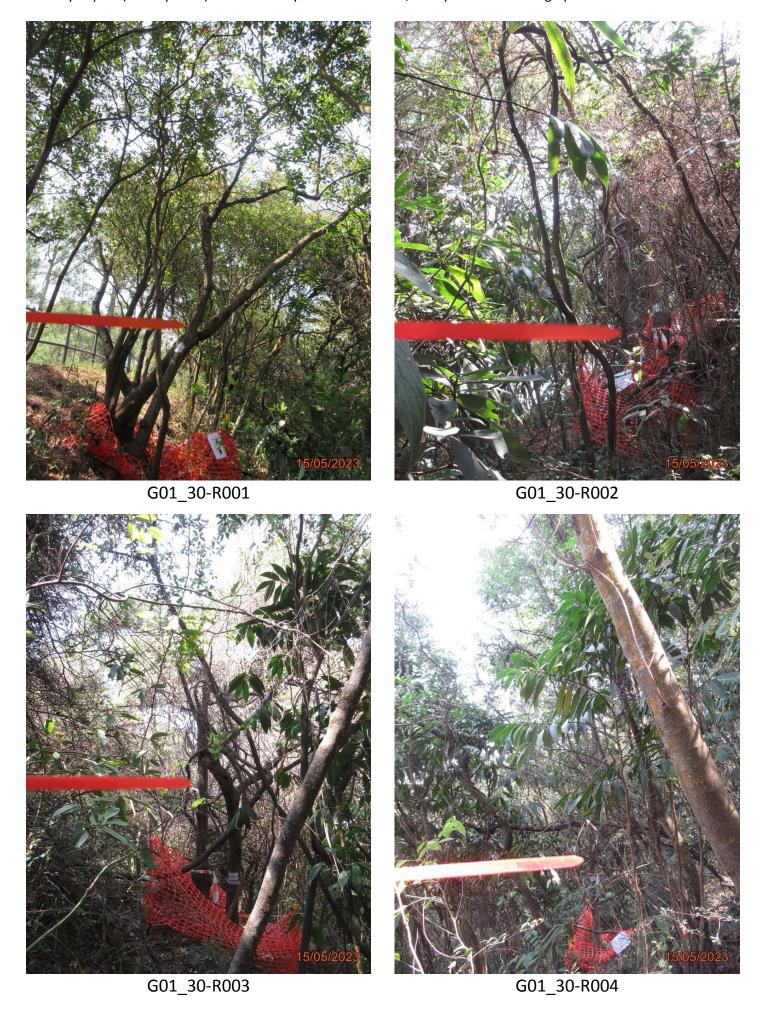
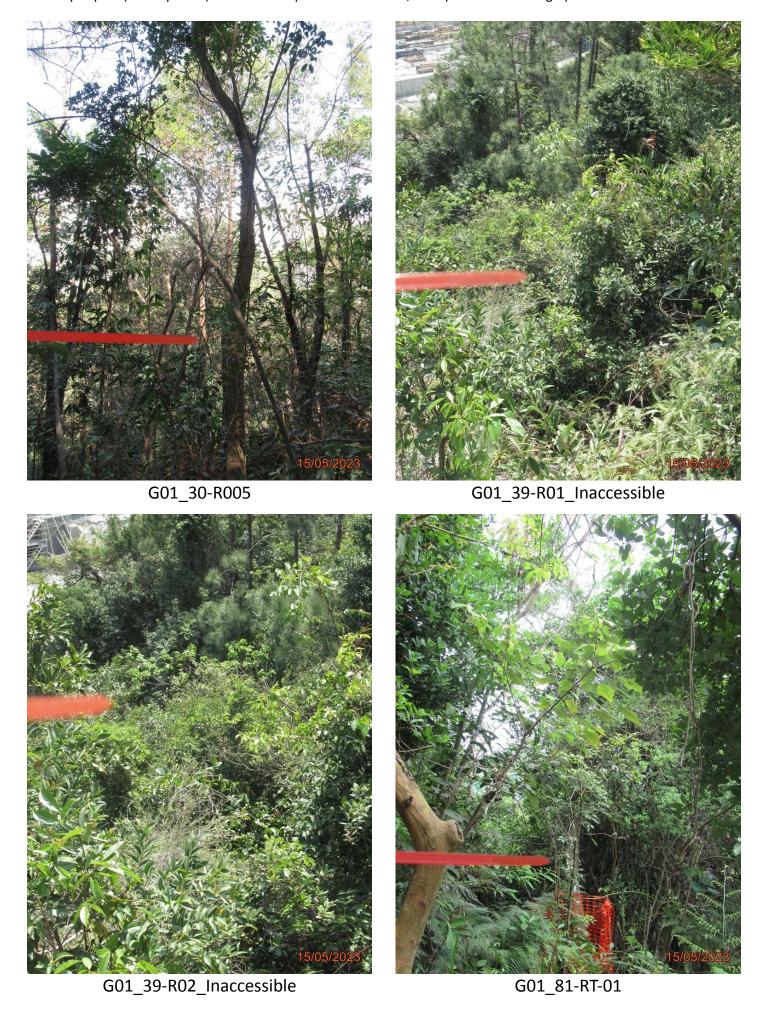
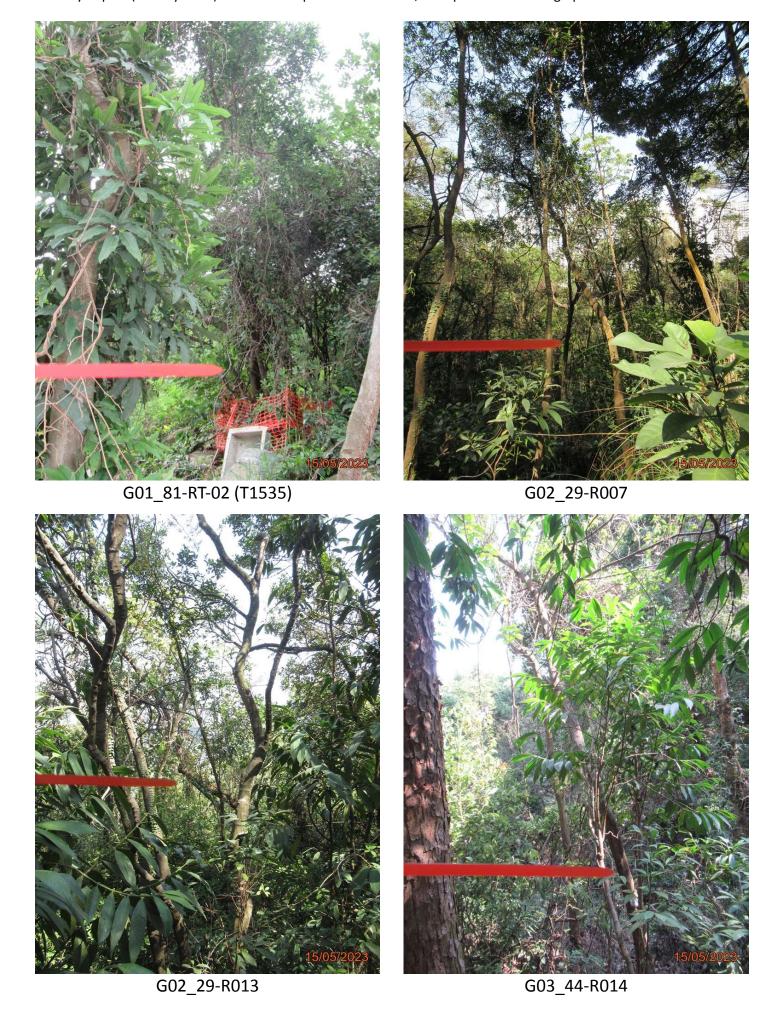
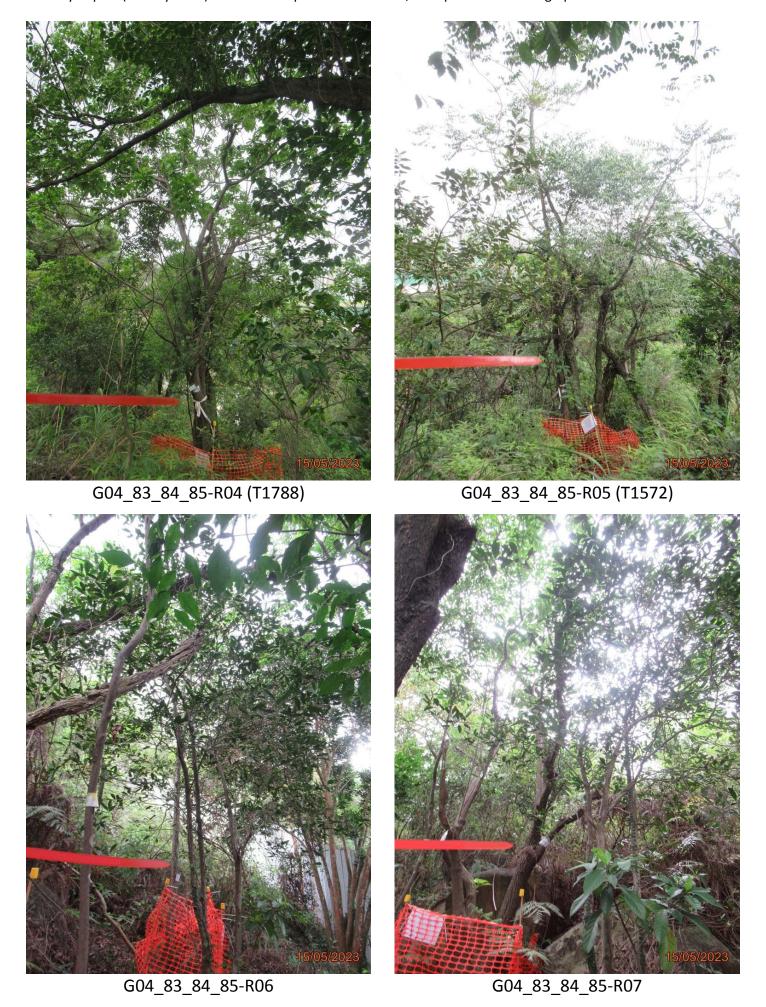
Monthly monitoring of the *in-situ* preserved plant species of conservation importance by the Qualified Personnel (QP) appointed under Contract 2 was implemented in the reporting period. Health condition was considered fair for the majority of the *in-situ* preserved plant species of conservation importance, of which two individuals of *Gmelina chinensis* could not be monitored as a result of unsafe access to the locations, as recorded during the monitoring carried out on 15 May 2023.

Tree protection zones for the *in-situ* preserved plant species of conservation importance were demarcated. No injuries and/or damages to the individuals of the *in-situ* preserved plant species of conservation importance were reported by the QP since the previous monitoring events. Photographic record and tree schedule of the preserved plant species of conservation importance monitoring are provided in *Annex I1*.

Tung Chung New Town Extension - Salt Water Supply System
Monthly Report (15 May 2023) In-situ Plant Species of Conserva, on Importance - Photographic Records

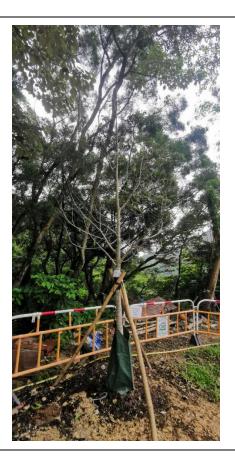
Monitoring of the replacement planting of *Aquilaria sinensis* was carried out on 24 May 2023. Individuals of the replacement planting trees were in healthy condition with insignificant signs of pest infestation observed. Insecticide was applied on 27 May 2023 to prevent pest. Photographic record of *Aquilaria sinensis* monitoring are provided in *Annex 12*.

Photo 01: Whole view of 3nos. Aquilaria Sinensis

Photo 02: Whole view of RP01

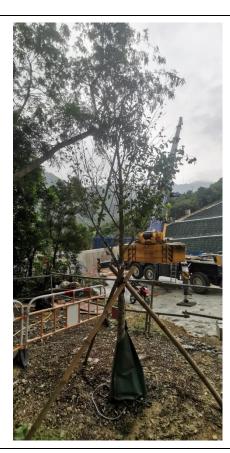
Photo 03: Whole view of RP02

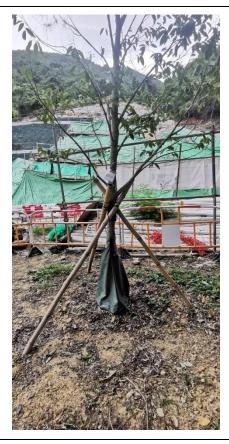
Photo 04: Whole view of RP03

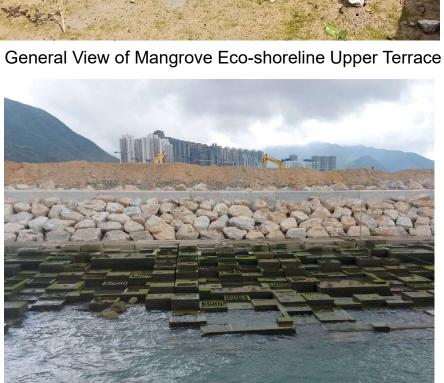
General View of Rocky Eco-shoreline

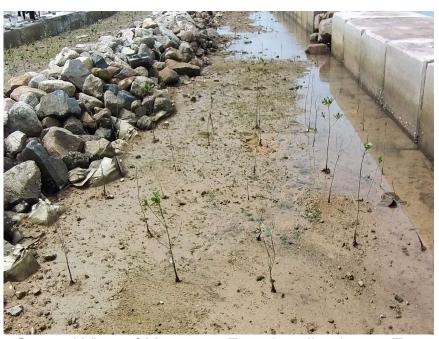
General View of Mangrove Eco-shoreline Lower Terrace

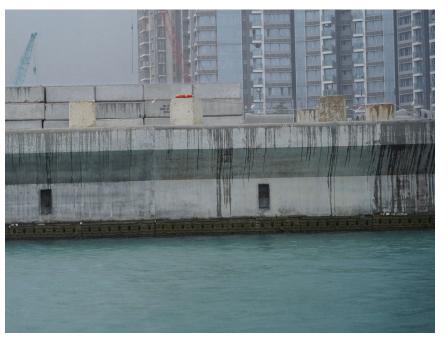
General View of Vertical Eco-shoreline

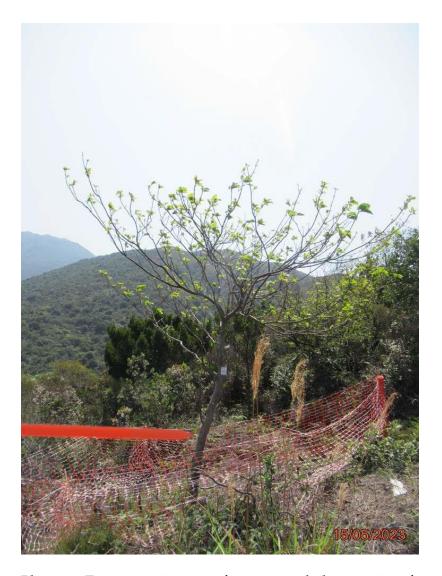
Photo 1 – Tree protection zone for preserved plant species of conservation importance

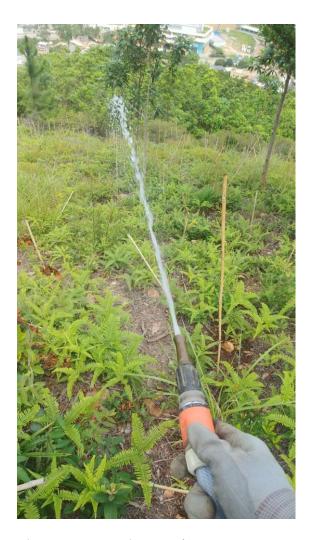
Photo 2 - General view of compensation woodland
